# *Complete Home Inspections LLC*

## Property Inspection Report

1001 W 1st St., Muncie, IN 47305

Date of Inspection: 8/2/2026 Time: 10:00am

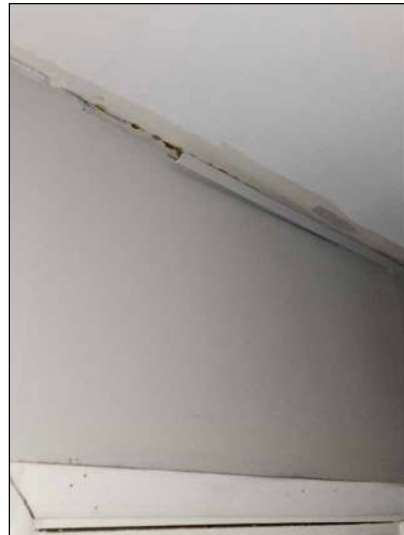
#### 6. Ceiling Condition

- There were several areas that were unfinished or had minor deterioration of the plaster ceilings. No active leaks observed at the time of the inspection. Recommend further evaluation by a qualified contractor.

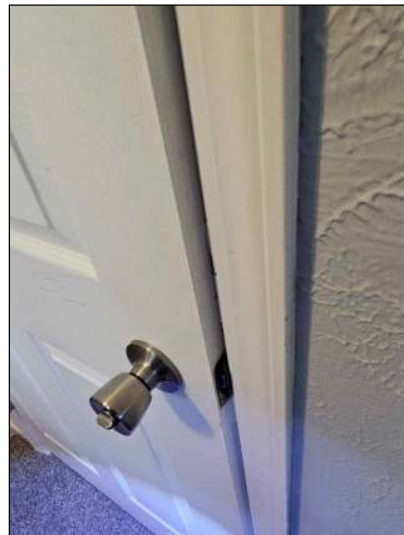
- Issues with operating every door in the house. Tight fitting. Difficult to open and close or does not latch properly. Recommend repair by a qualified contractor.

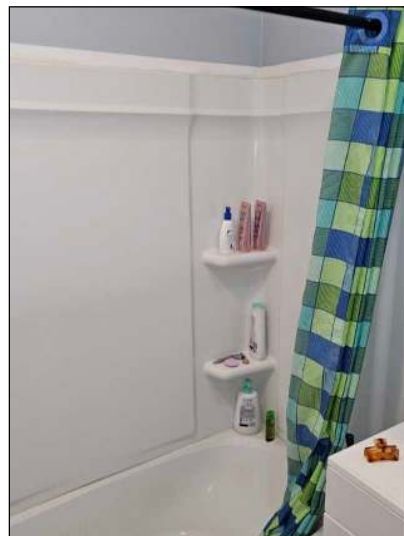
### 15. Bath Tubs

Observations:  
• Bathtub noted

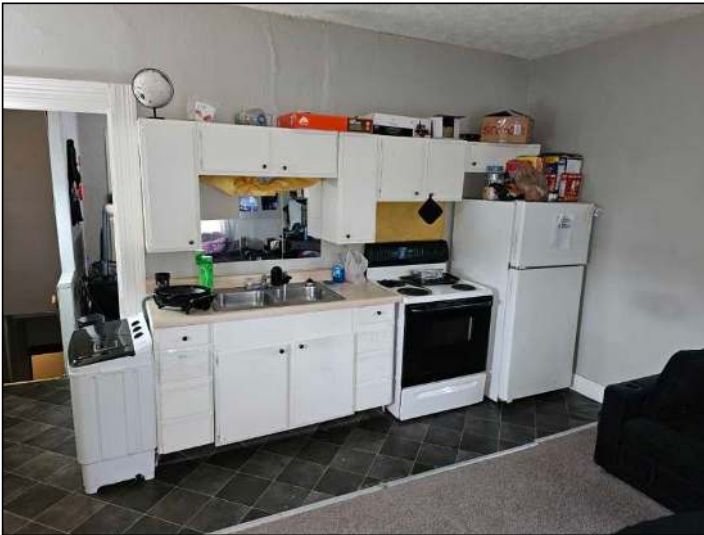
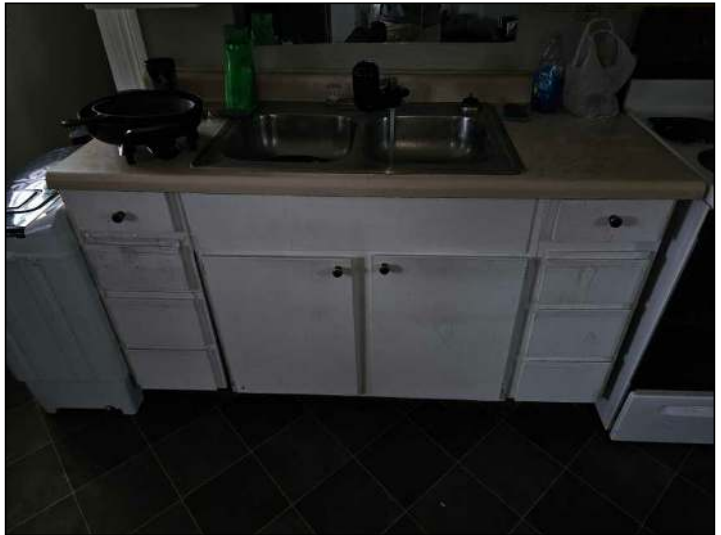
- Cabinets appeared to be beyond the expected lifespan. Consider upgrading
- Some cabinet doors need magnets or hardware to stay shut. Repair as needed.
- Some cabinet drawers need hardware repair/adjustment (to stay shut). Repair as needed.

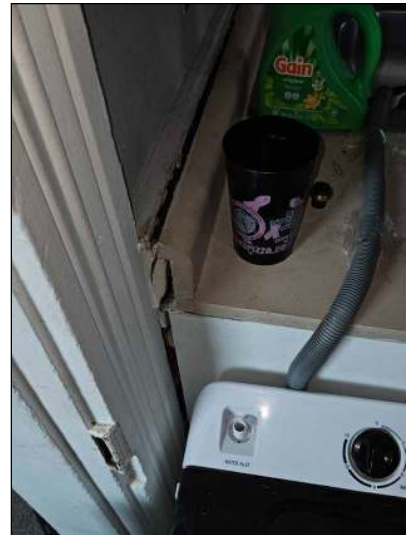
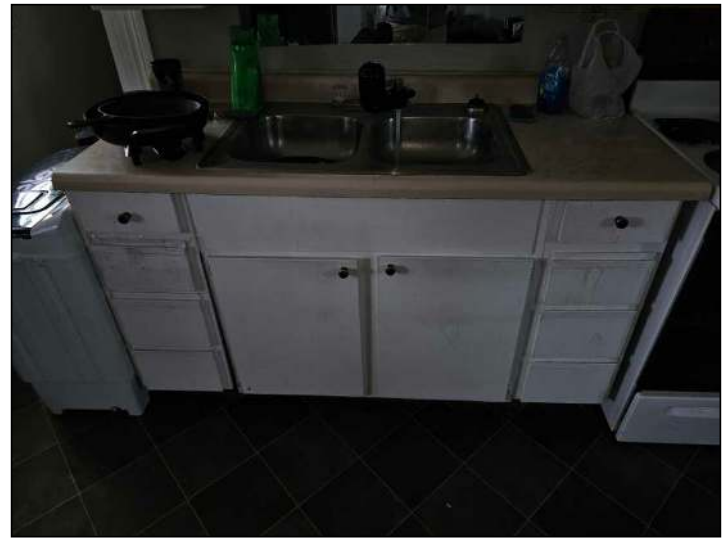
## 2. Counters

- Plastic laminate tops noted.
- Particle wood exposed on edge of the countertop in the kitchen of unit #1. This makes the countertop susceptible to moisture damage. Recommend repair by a qualified contractor.
- Countertop in the kitchen of unit #2 appears to be beyond the expected life span of the material. Recommend considering new cabinets and countertop.

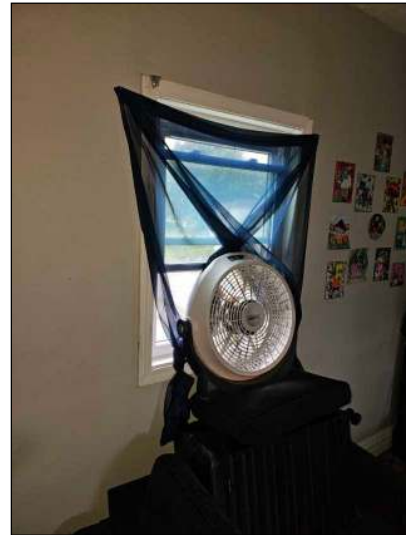
## 9. Window Condition

- Operated windows appeared functional, at time of inspection.
- Not all windows were tested due to personal items and furnishing obstructing the windows.

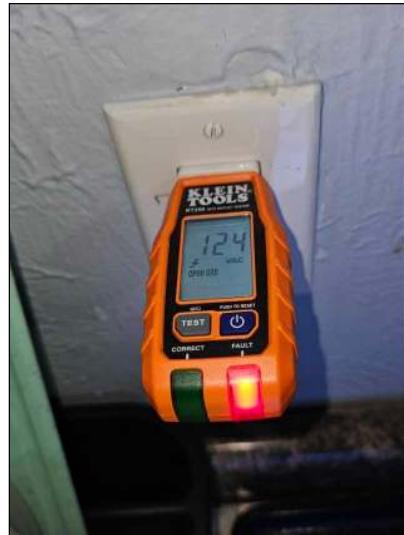
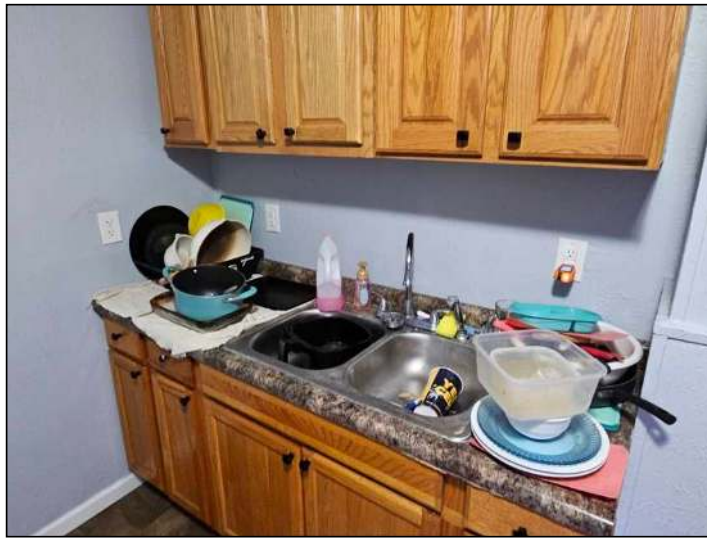
- Not all outlets in the kitchen were GFCI protected. While it may not have been required when the house was built. We suggest buyer consider upgrading with GFCI's at all receptacles near water sources.
- GFCI tested and found to be improperly wired. Potential shock hazard in a high moisture area. Recommend review and repair by a licensed electrician.

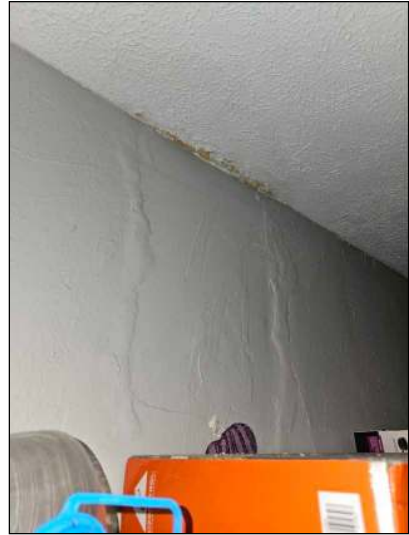
### 15. Wall Condition

- Limited review due to storage of personal property and finished walls.
- There is evidence of moisture entering structure in the kitchen in unit #2. We recommend contacting a contractor experienced in exterior systems to evaluate the area and suggest repair options.
- Paper covering wall above stove is possible obstructing damage to the wall.

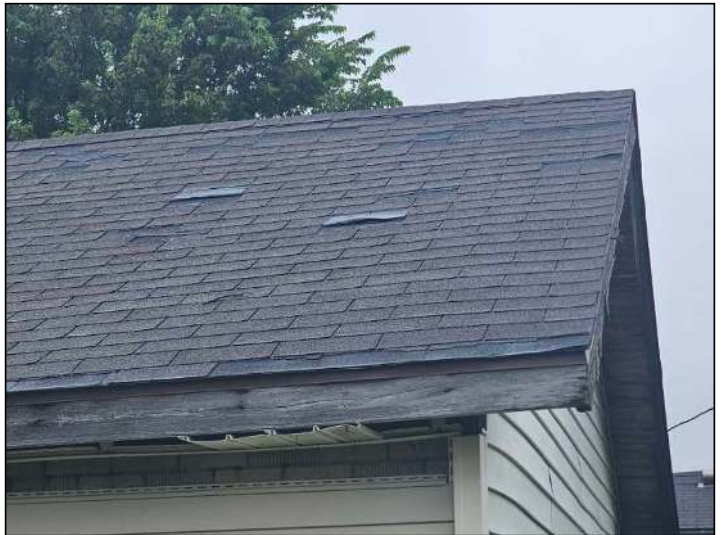
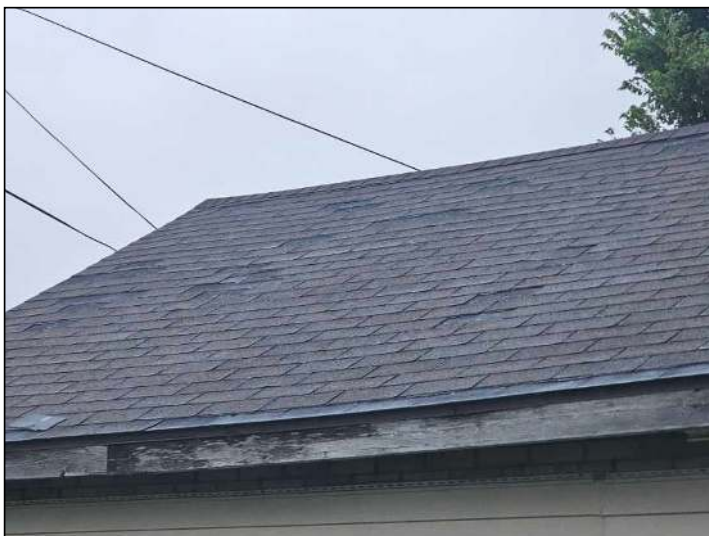
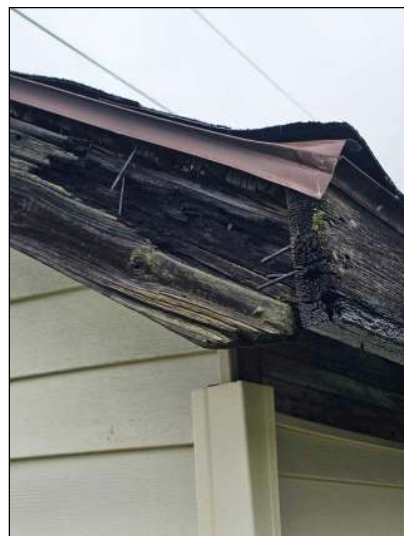
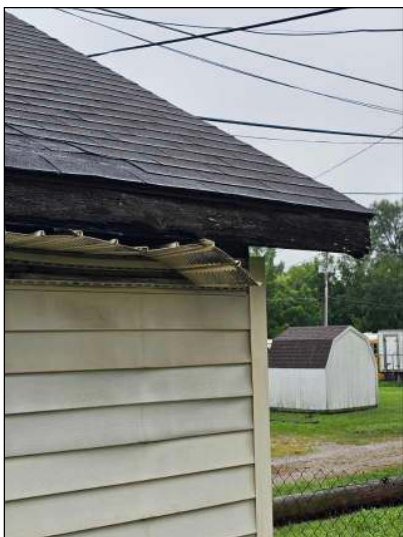
## 1. Roof Condition

- Some shingles and/or tabs missing.
- Some shingles damaged.
- Roof sheathing has been damaged.
- Indications of past or present water leaks, seeps, or condensation at eaves.
- Recommend further evaluation for repair/replacement by a qualified roofing contractor.
- Deterioration of exposed wood noted at the eaves around the garage. Recommend repair by a qualified siding contractor.

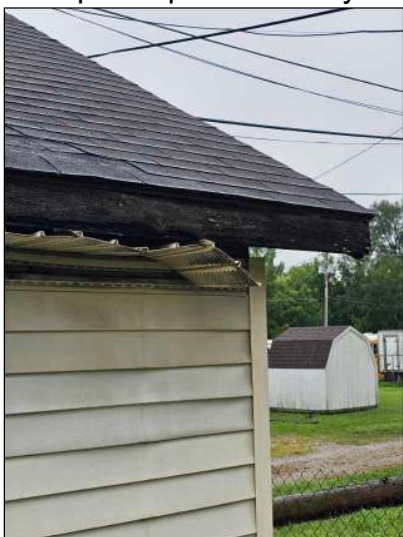
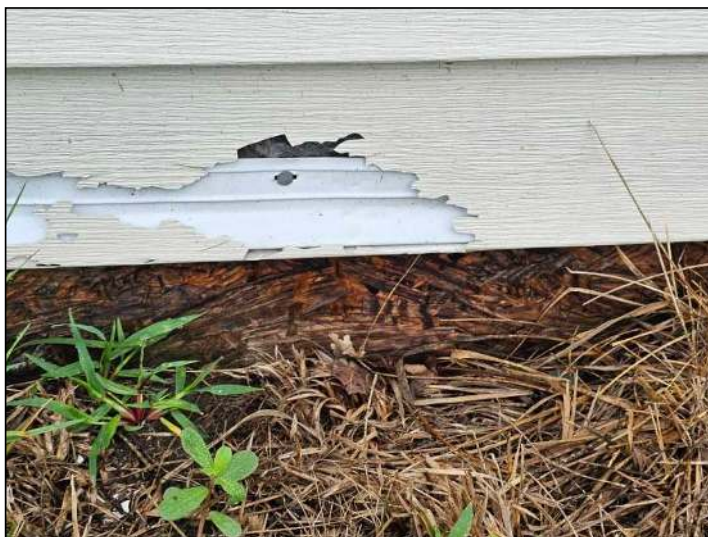
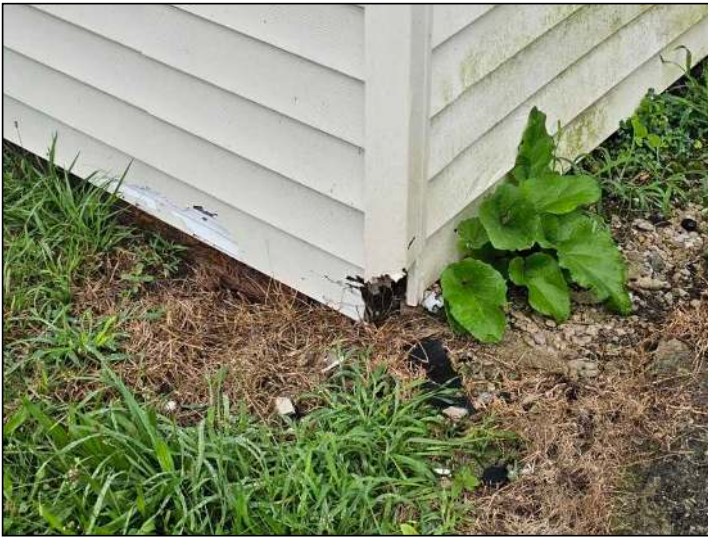
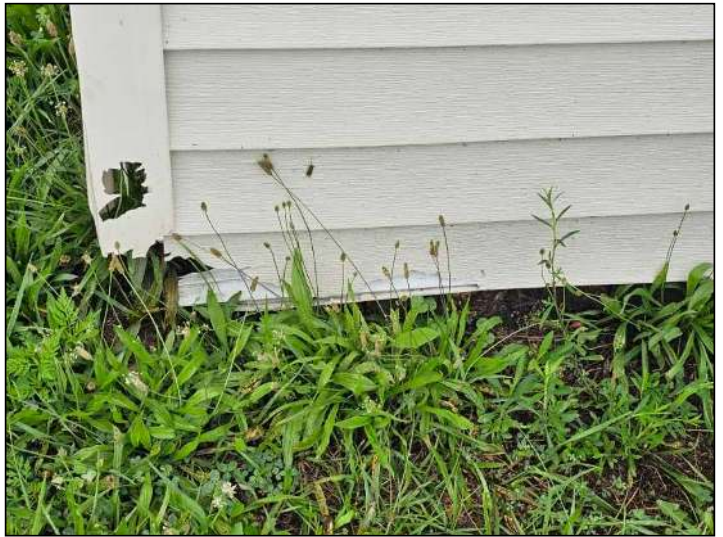
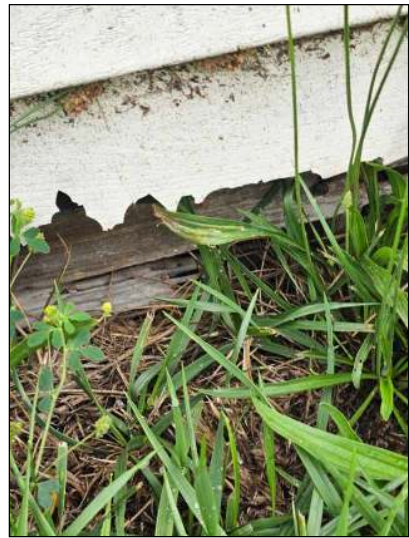
## 2. Walls

- The interior of the detached Garage/Shed could not be inspected due to restricted access. No key was available to unlock the exterior door at the time of inspection.
- Exterior siding is missing and damaged in multiple areas and is in close proximity to the ground. These issues can allow water damage to occur. Recommend repair/replacement by a qualified contractor.

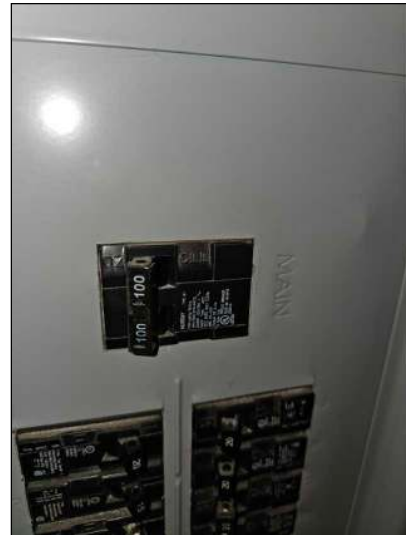
- Open breaker panel slot(s) at panel box cover in unit 2. Electrocution hazard. Recommend repair by a licensed electrician.

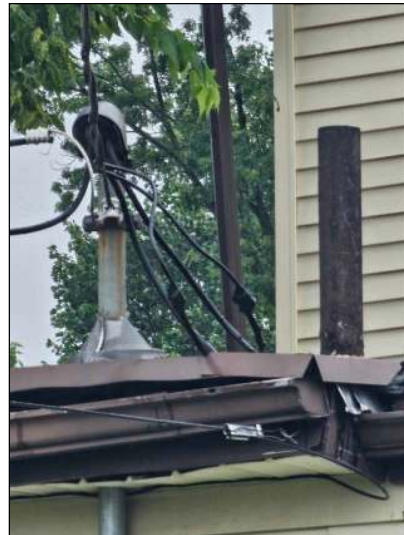
- There is an overhead service drop noted.
- The weather head is too low and the driploop is resting on the metal roof, this is a serious safety concern. Recommend review by a licensed electrician for repair or replacement, as necessary, prior to close.

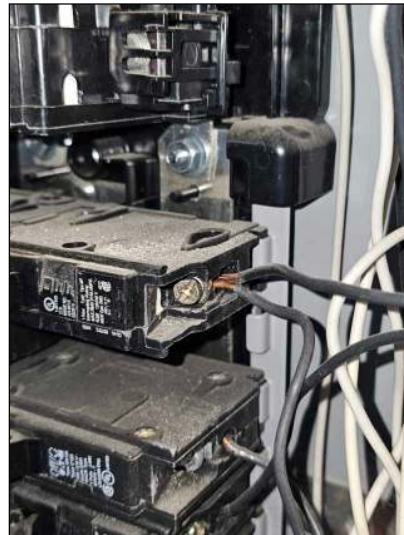
## 5. Breakers

- All of the circuit breakers appeared serviceable in both units with exception of one breaker that had a broken switch in unit 1. Recommend replacement by a licensed electrician.
- Double tapping observed in unit #1. Double tapping (i.e. 2 wires on a single pole breaker) can add to the load of the affected circuit causing a possible overload and tripping breakers, or result in loose connections and overheating of the breaker or connections. Recommend further evaluation and repair by a licensed electrician

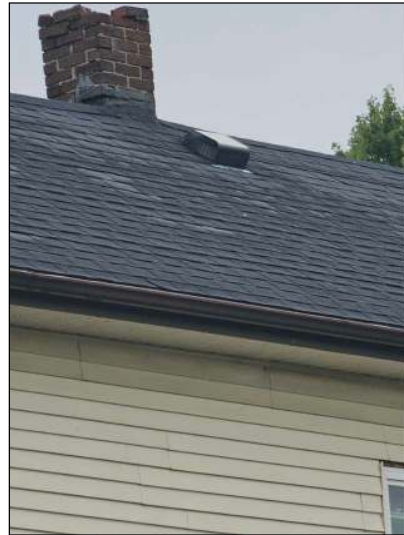
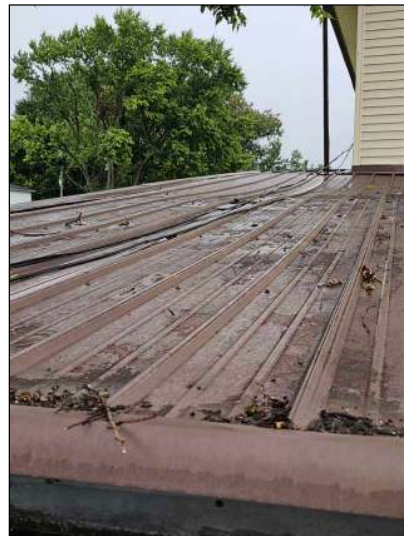
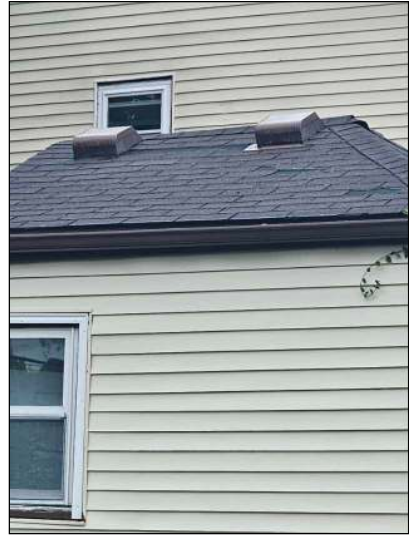
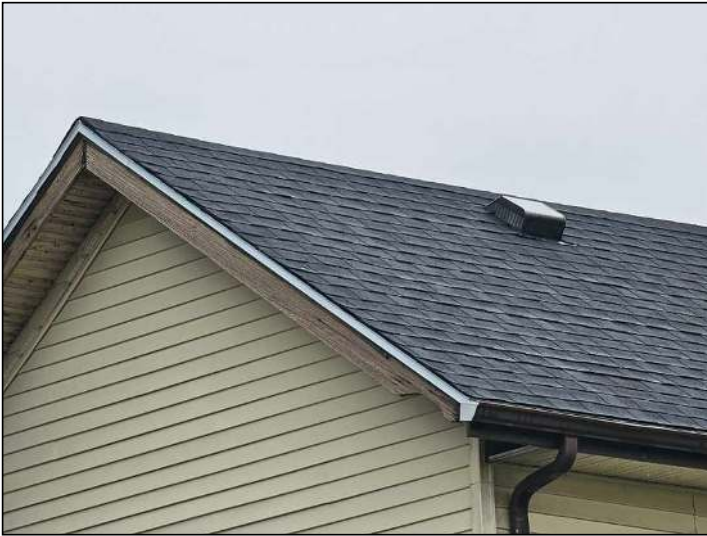
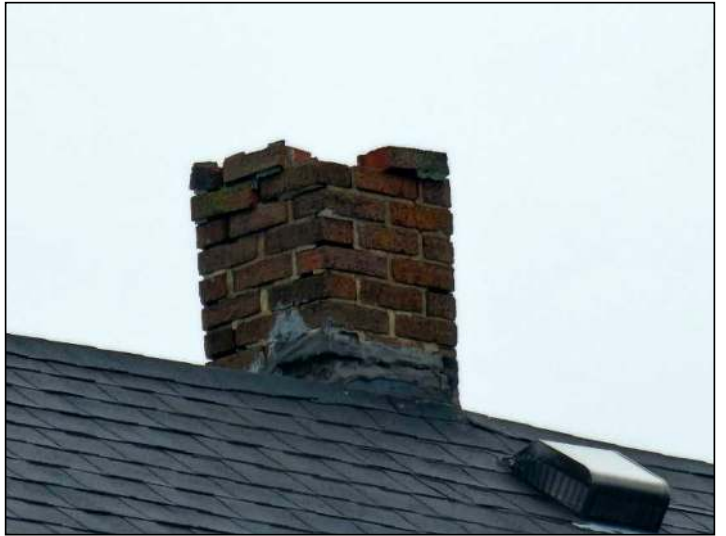
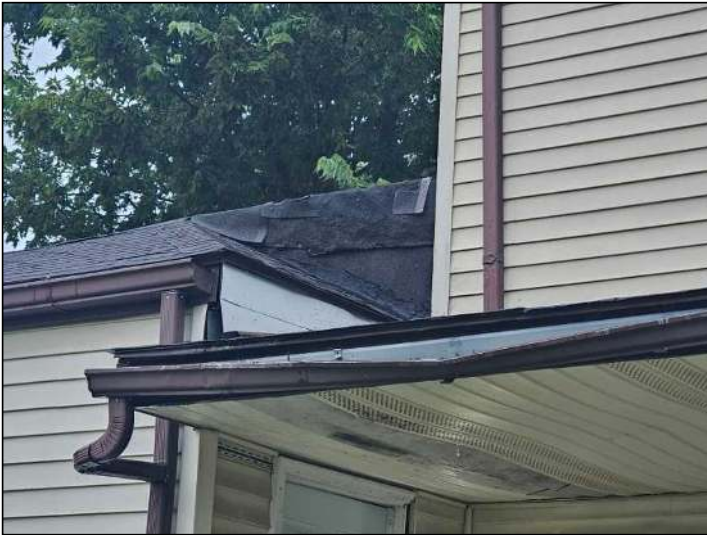
## 1. Roof Condition

- Some shingles &/or tabs missing.
- Some shingles curling.
- Some shingles damaged.
- Recommend roofing contractor to evaluate.

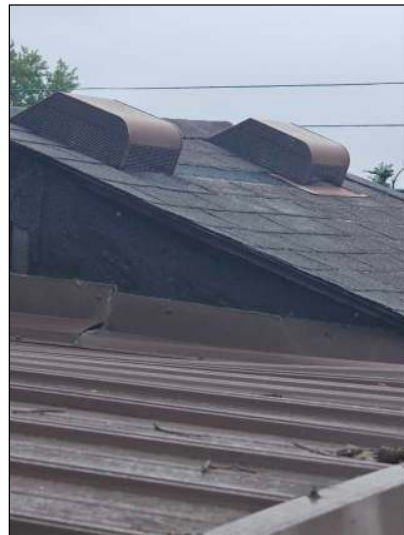
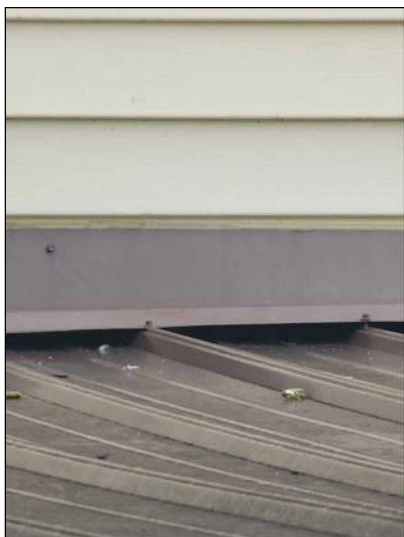
## 2. Flashing

- Flashing is missing around the chimney. Recommend a qualified roofing contractor to further evaluate the roof.
- The caulking was deteriorating on the flashing around the metal roof. Recommend resealing to prevent leaks.

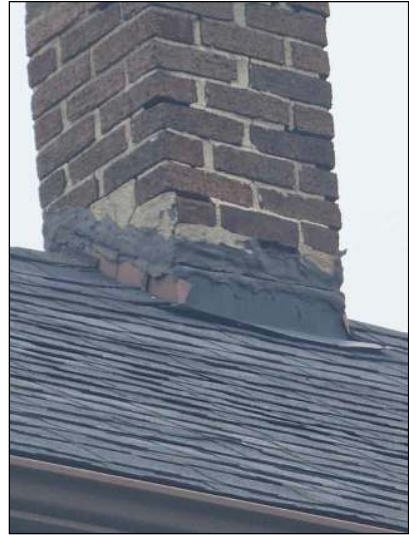
### 3. Chimney

- No chimney cap visible from inspection level. Recommend installation to prevent weathering, water intrusion, and nesting of wildlife.
- Chimney Mortar shows sign of deterioration. Recommend having repaired as necessary.
- Brick and mortar deterioration observed; repair advised.

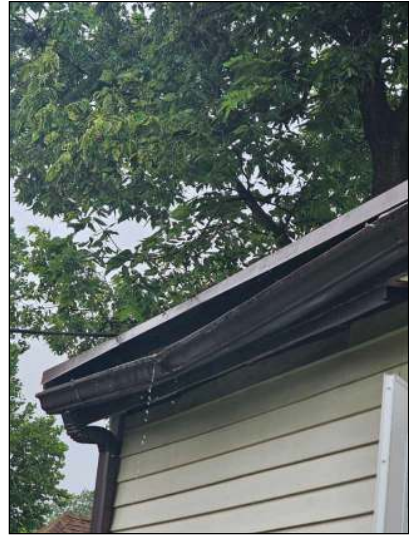
- The gutters were damaged or missing in multiple areas around the house. Recommend further review and repair/replacement as necessary by a qualified gutter company to keep water away from the foundation.
- Missing/fallen downspouts noted.
- Downspout on the south side of the house discharges straight down towards foundation. Suggest adding a splash block or extension.

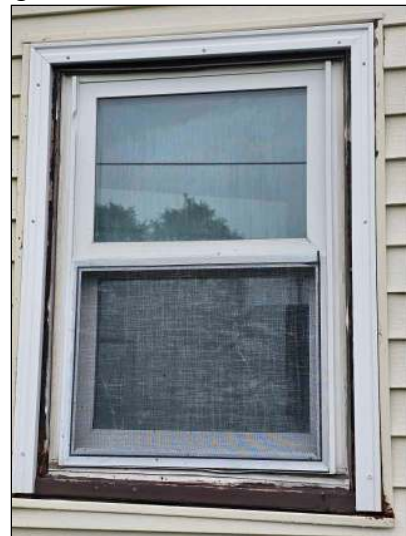
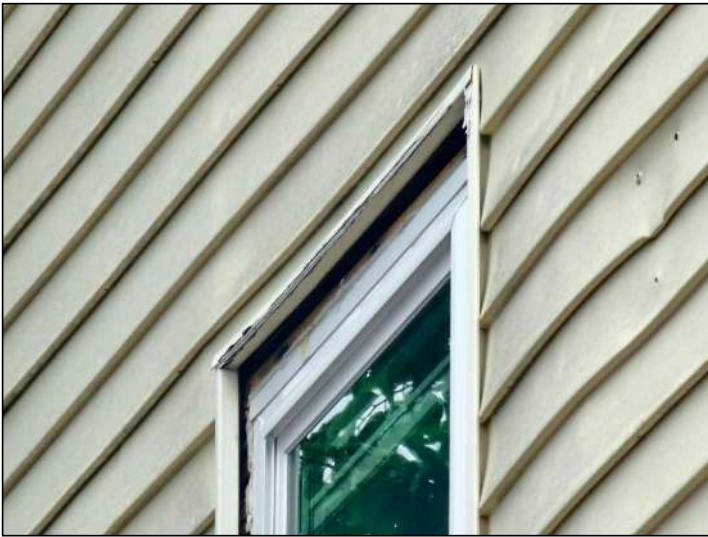
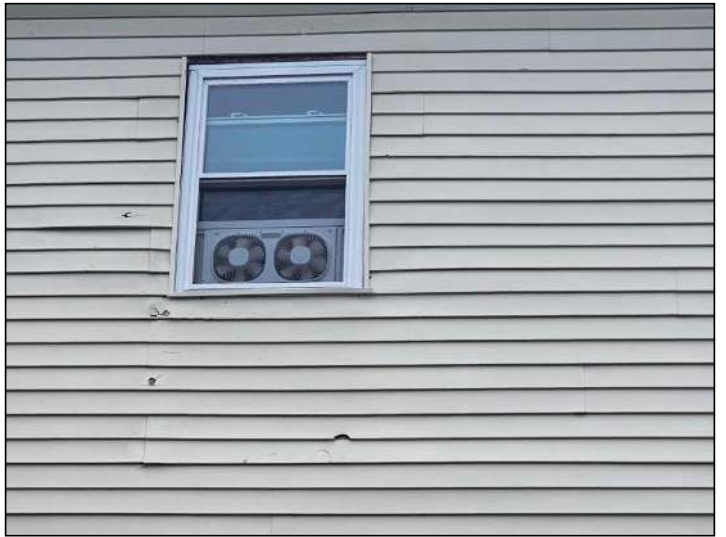
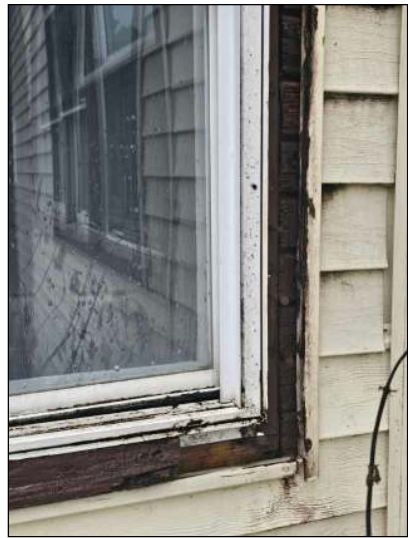
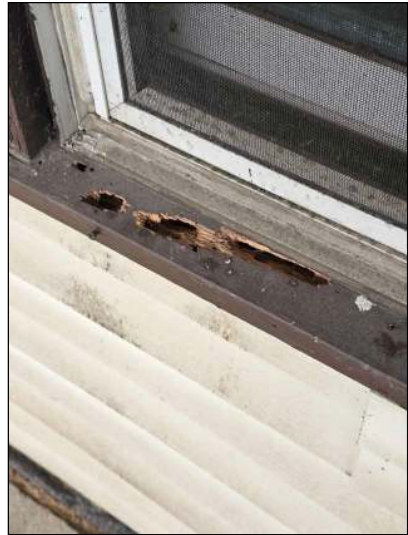
## 2. Window Condition

- Some window screens missing or damaged.
- Deteriorated exterior wood trim noted on several windows. Recommend repair/replacement by a qualified contractor.
- There is exposed wood around several of the windows. This can cause moisture damage. Recommend repair by a qualified siding contractor.

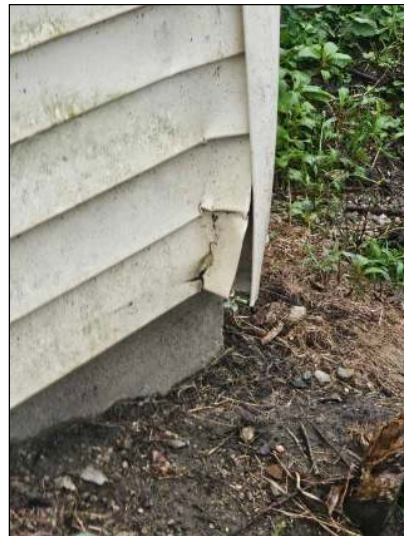
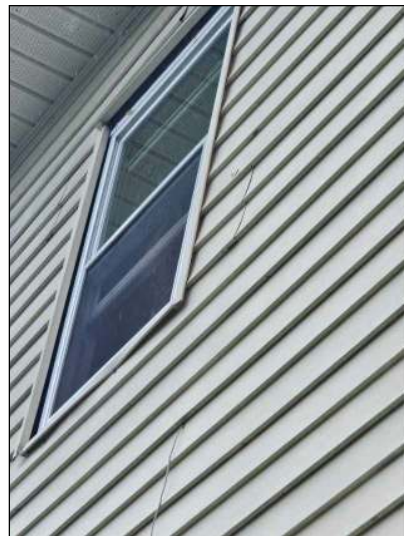
### 3. Siding Condition

- The siding is in close proximity to the soil. This may provide entrance for moisture or insects.
- Vinyl siding missing, damaged or improperly installed in multiple areas exposing the wood sheathing and can cause moisture damage. Recommend further evaluation by a qualified siding contractor.
- Warped siding present in some areas; recommend repair or replacement as necessary.
- Insect damage or activity suspected. Recommend further evaluation by a licensed exterminator.
- Some wood deterioration noted at garage - exterior personnel door frame base. Have repaired and inspected for wood-destroying insect damage.
- Moderate damage to vinyl: The vinyl siding covering exterior walls had areas of moderate damage which should be repaired to prevent moisture intrusion of the wall assembly.

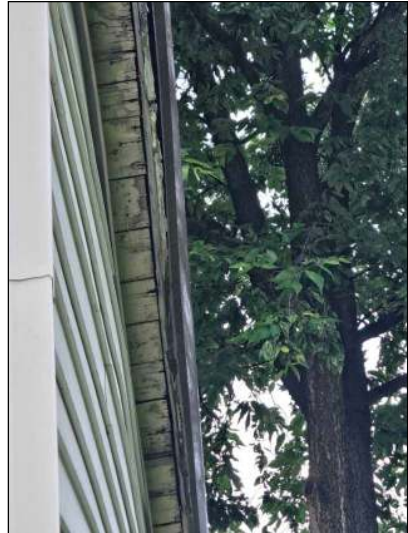
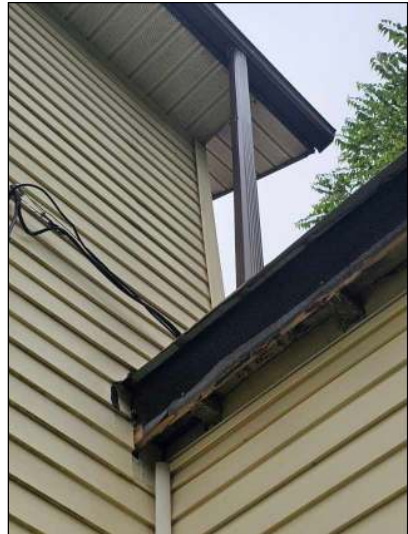
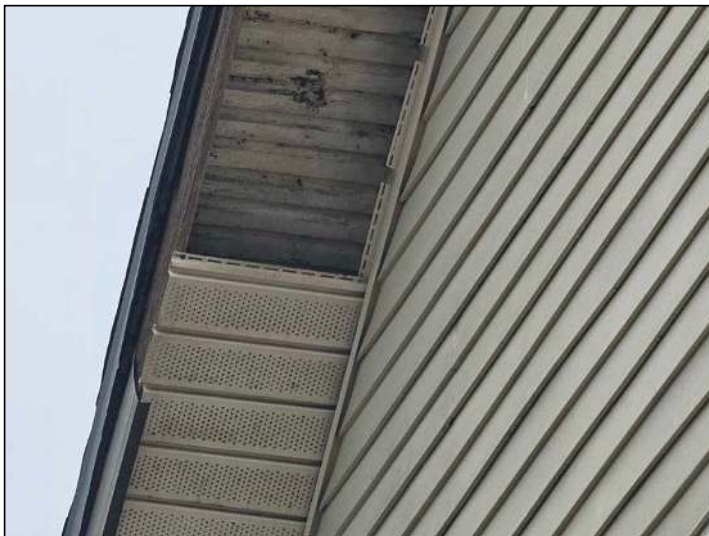
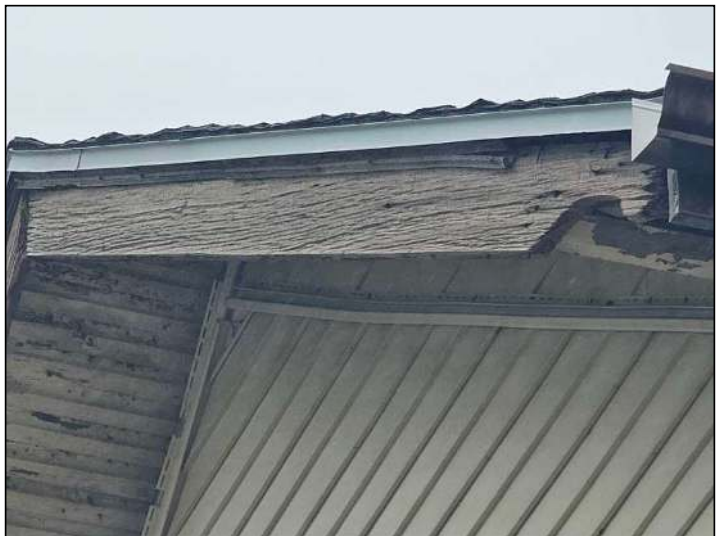
- In the inspectors opinion the trim is near the end of its useful life
- Moisture damage, wood rot, observed. Recommend review for repair as necessary by a qualified contractor.

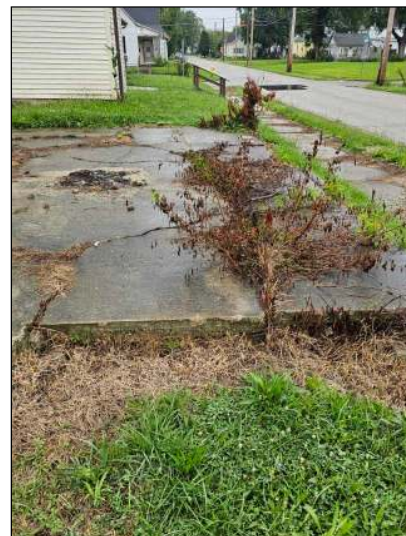
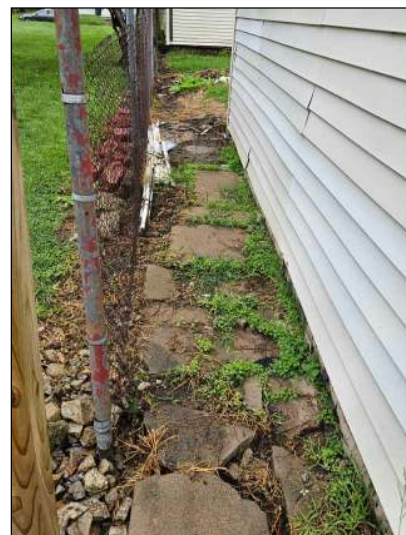
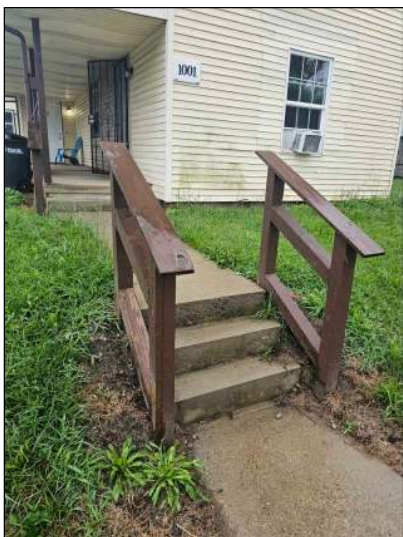
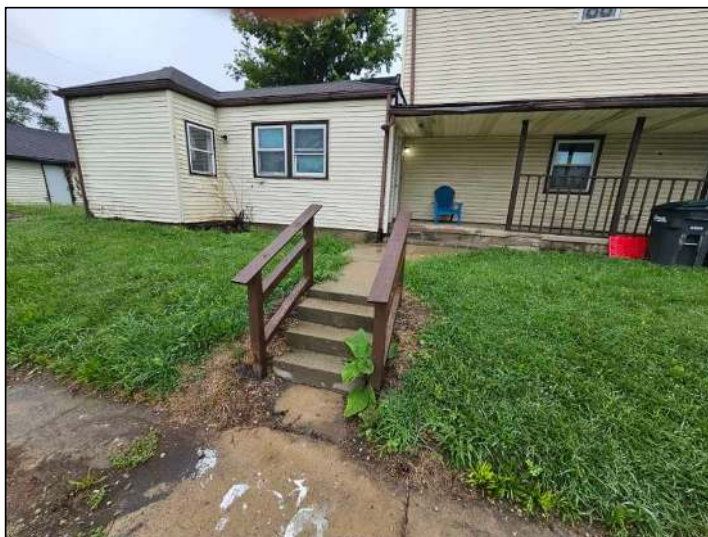
- There are numerous areas of damaged concrete surfaces. Concrete replacement is expensive. Recommend a concrete specialist provide an estimate for repair and or replacing.
- Monitor: Surface deterioration observed at the concrete surface.
- Potential Trip/fall Hazard(s) at the sidewalk steps and old concrete pad located in the backyard; monitor/ repair as necessary.
- Handrail on sidewalk steps is no graspable by today's standards and is a potential fall hazard. Recommend a qualified contractor to replace handrails.
- Sidewalk along the garage/shed is severely deteriorated and is a potential tripping/fall hazard. Recommend repair by a qualified contractor.

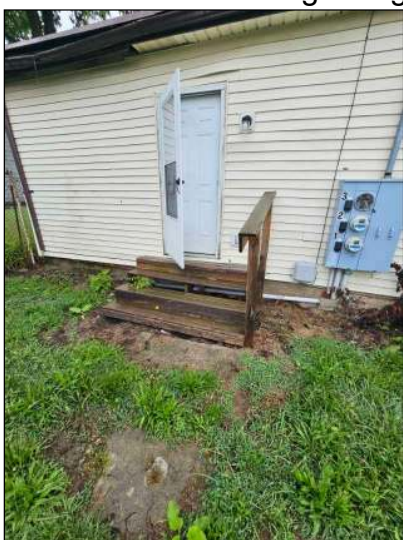
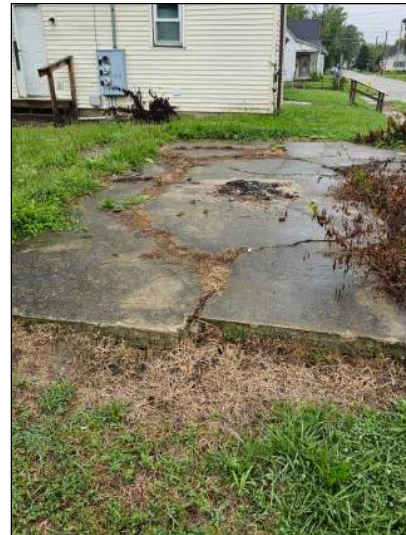
## 2. Grading

- The exterior drainage is generally away from foundation except on the west side of the house is flat. Evidence of moisture and organic growth present. Recommend further review by a qualified contractor.
- Low and settled grading was observed at north west corner. Fill as needed.

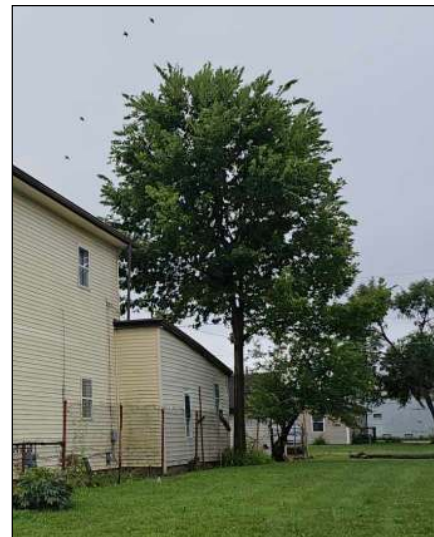
### 3. Vegetation Observations

- There is a tree on the neighboring property that is within 6 feet of house. Monitor for potential root damage to the foundation and possible damage to the roof from tree limbs.

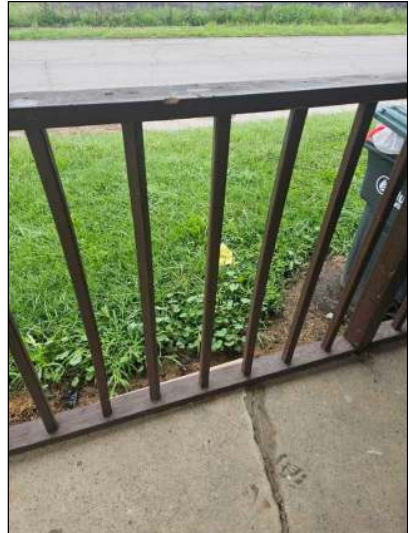
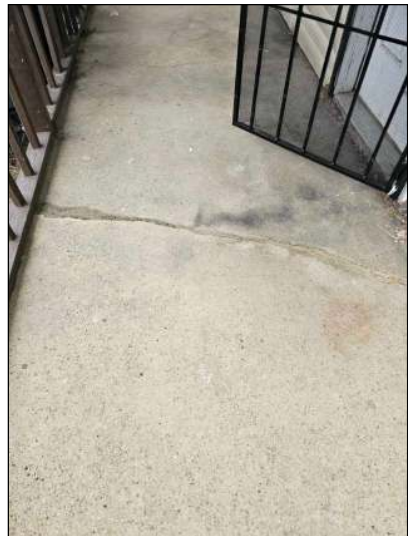
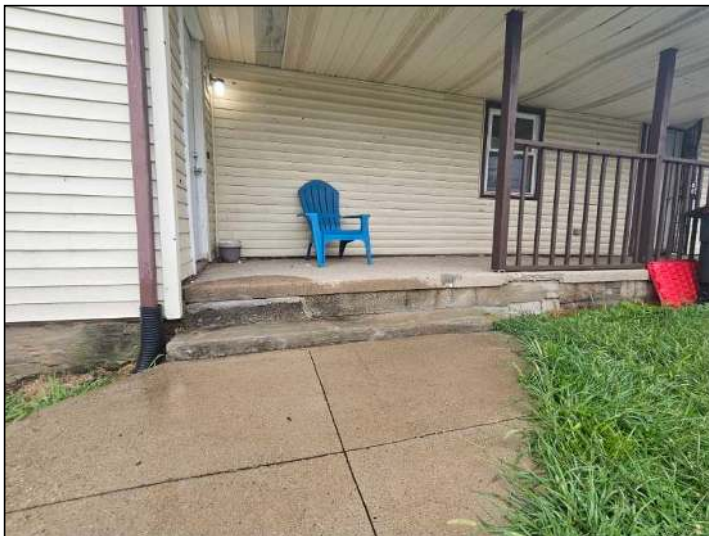
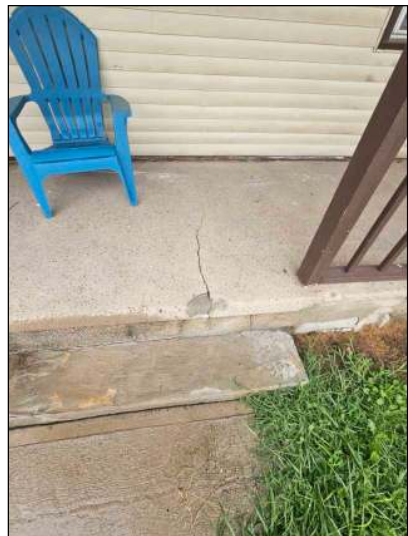
### 4. Patio and Porch Deck

- Balusters spaced too far apart.
- Non-conforming steps on the front patio, possible safety hazard.
- The steps are slanted on the back door of the downstairs unit and present a possible slipping hazard.
- Front concrete patio has a large settlement crack that caused the surface to be uneven. This is a potential tripping hazard. Recommend repair/replacement by a qualified contractor.

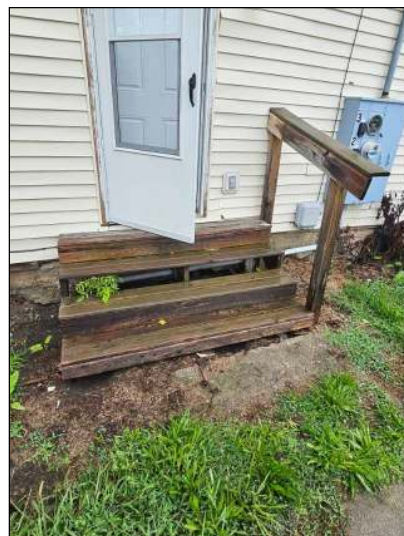
## 5. Stairs & Handrail

- Handrails are not graspable. By today's standards, rails should be configured so that a hand may grasp around a rail for safety. Recommend replacement by a qualified contractor.

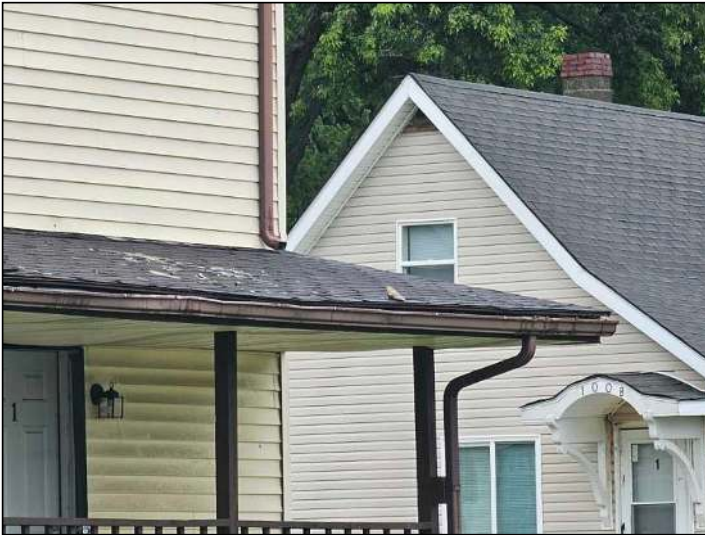
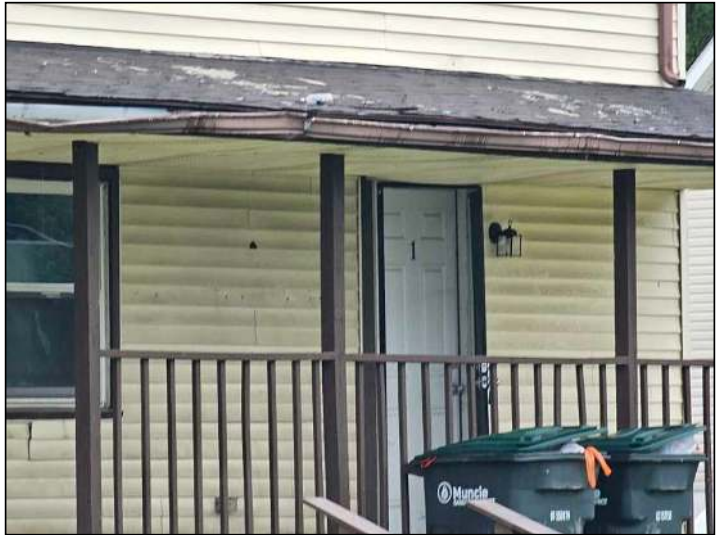
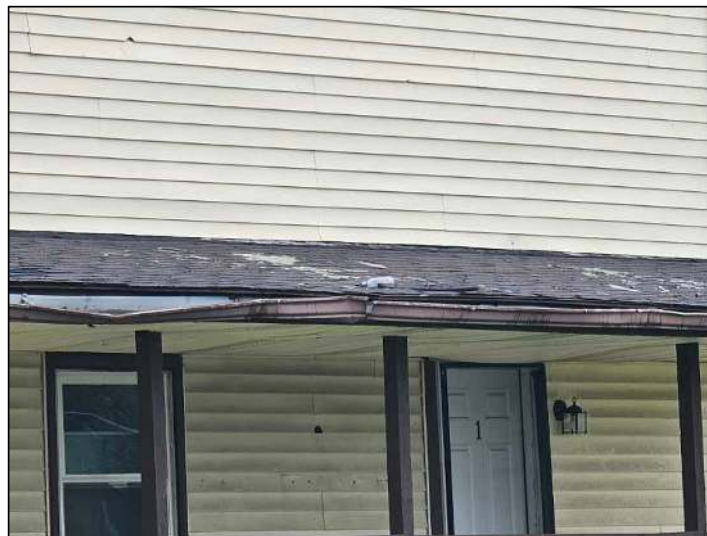
- Some shingles damaged.
- Serviceability of roof is questionable; it should be evaluated and repaired as necessary by a professional roofing contractor.
- Note that experts recommend that any roof over 10 years old receive a roof certification by a local roofing specialist.

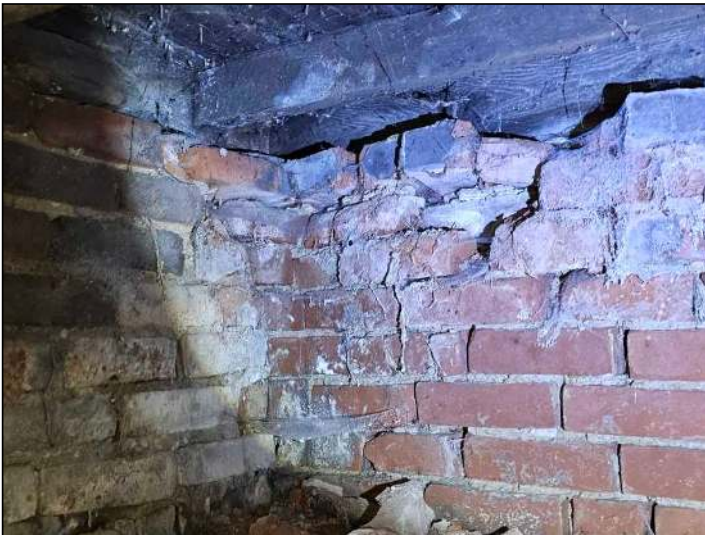
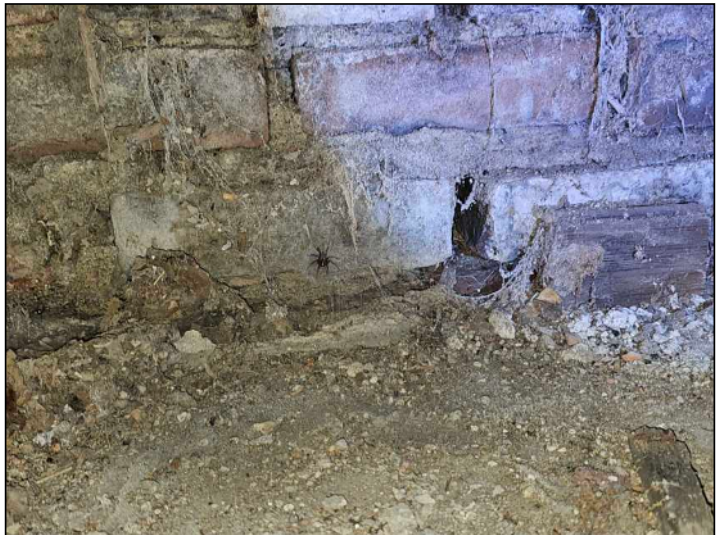
- It had rained heavily the day before and was misting at the time of inspection. Recommend having a licensed plumber
- Visible portions of foundation wall were dry at the time of the inspection.
- Large cracks were observed at the visible foundation walls. Repairs can be expensive and further settling or damage could occur. Recommend a Structural Engineer to provide a detailed analysis.
- The mortar in the brick foundation walls is deteriorating. Recommend further evaluation by a structural engineer.

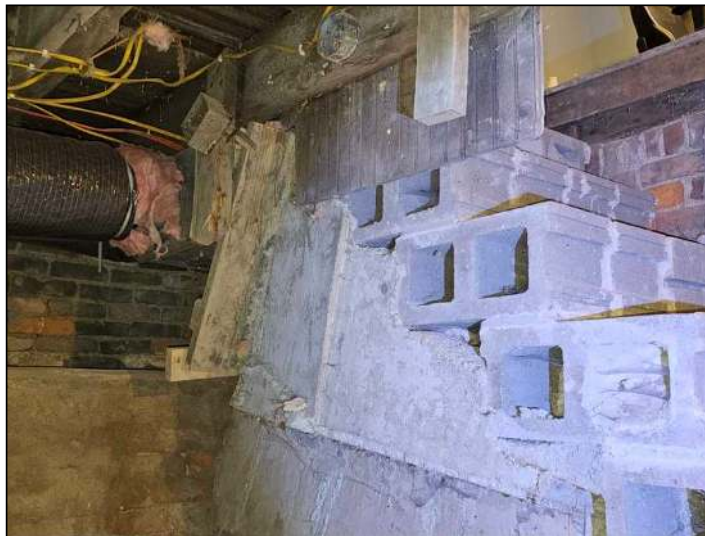
- Recommend review by a qualified professional for repair or replacement as necessary.
- Stairs have inadequate headroom, this is a safety concern.
- Unprofessional building practice/materials used, further review by a Qualified Contractor is recommended.

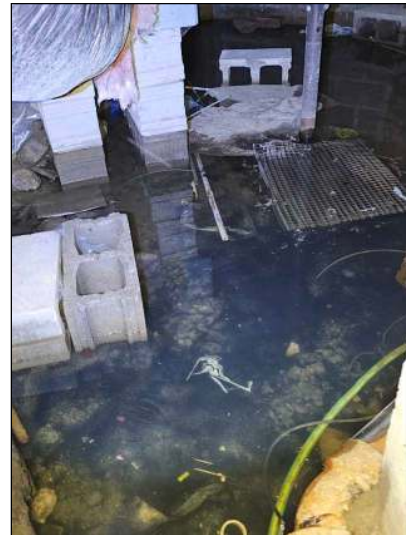
- Standing water noted on slab at time on inspection, review and repair needed to prevent possible water damage.
- Majority of the basement was inaccessible. Recommend a foundation specialist further evaluate the basement floor and walls once the standing water issue is resolved.

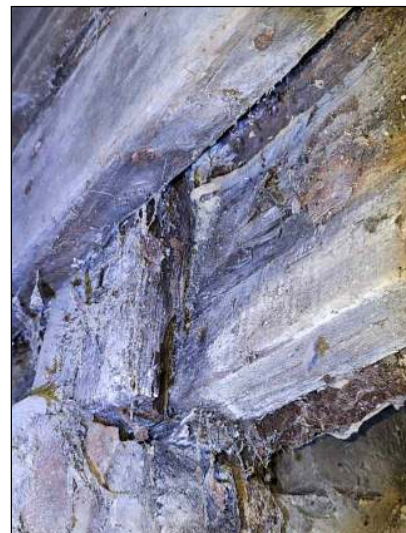
- **\*\*JOISTS\*\***
- Deterioration/ damage of one or more floor joist noted. Recommend review and repair by a Qualified Contractor to evaluate load bearing members.
- Recommend review of floor support system by a qualified contractor for any repair or upgrades needed to structure.
- Not fully visible for inspection due to lack of access to all areas.

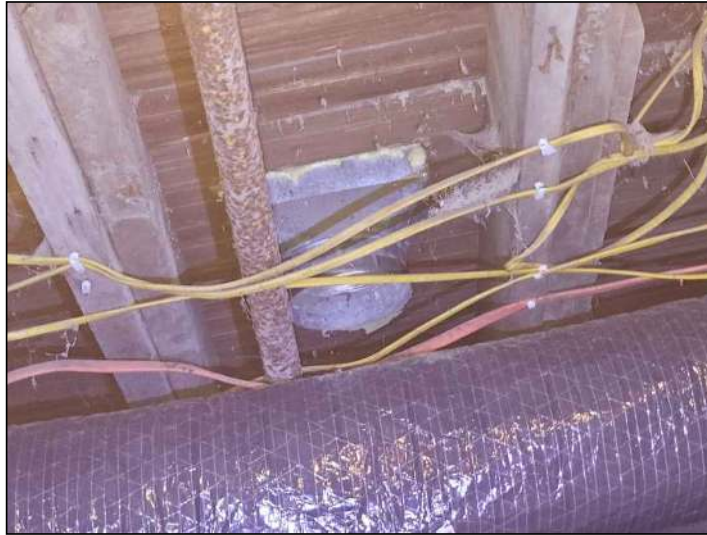
- Due to most of the basement being inaccessible the heating and cooling duct system needs reviewed and repaired as necessary by a Qualified Contractor.
- Unconnected ductwork noted in the basement.
