# *Complete Home Inspections LLC*

## Property Inspection Report

1001 W 1st St., Muncie, IN 47305

Date of Inspection: 8/2/2026 Time: 10:00am

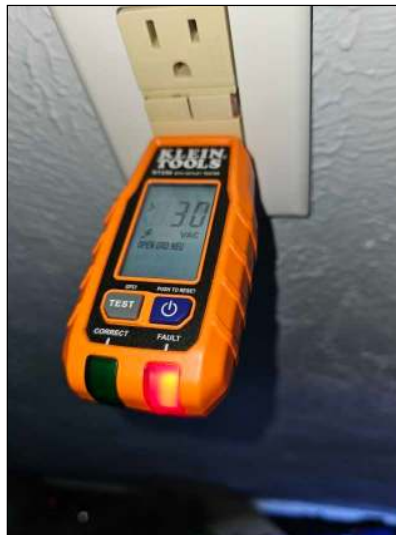
- Some outlets not accessible due to furniture and or stored personal items.
- **GFCI** outlet near the water heater was found to have an open ground/neutral fault when tested. This is an electrical shock hazard. Recommend repair by a licensed electrician.

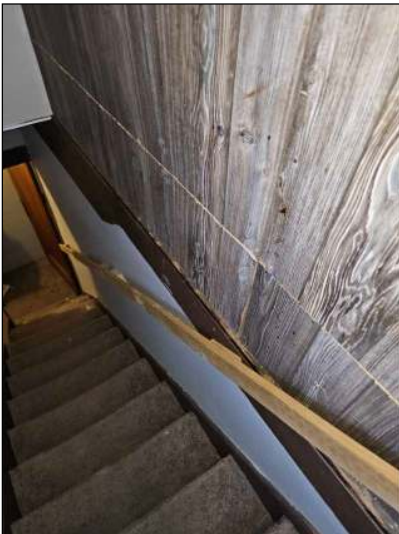
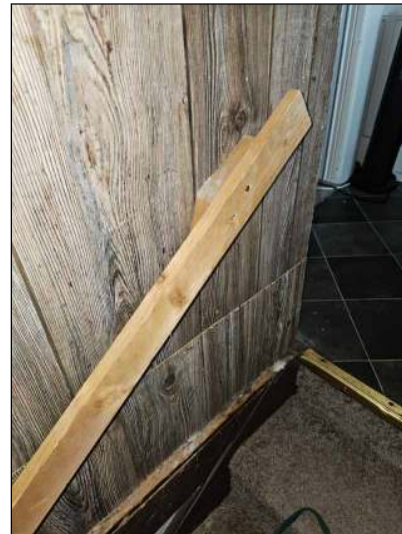
- Handrail is not 1.5 inches from wall.
- The riser and tread depth is not the same for each step and low ceiling height present a safety hazard. Recommend further evaluation by a qualified contractor.
- Makeshift handrail installed in unit #2 stairway. Safety hazard. Recommend installing a proper handrail by a qualified contractor.

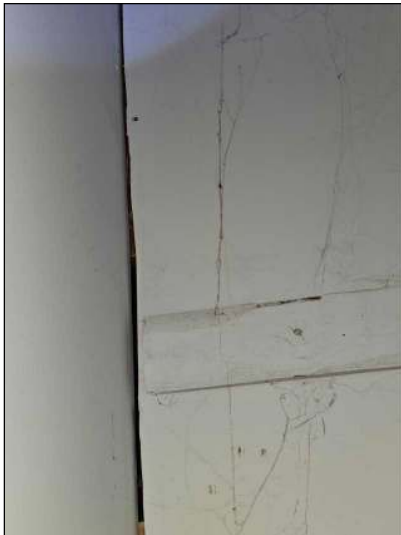
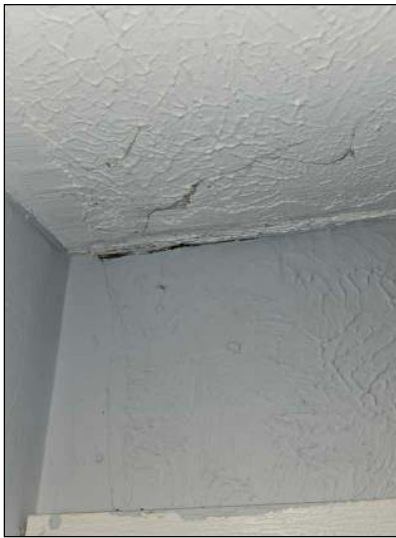
- There were several areas that were unfinished or had minor deterioration of the plaster ceilings. No active leaks observed at the time of the inspection. Recommend further evaluation by a qualified contractor.

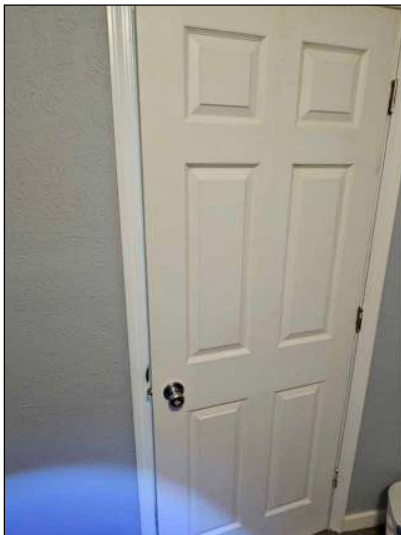
- Issues with operating every door in the house. Tight fitting. Difficult to open and close or does not latch properly. Recommend repair by a qualified contractor.

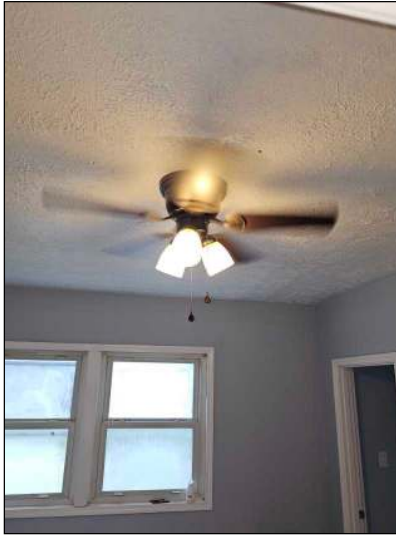
• One or more bedroom window/s shows sign of loss of seal/condensation, recommend repair or replace for energy efficiency.

• Most of the operated windows appeared functional, at time of inspection but due to exterior conditions it is recommended to have the windows further evaluated by a qualified window contractor.

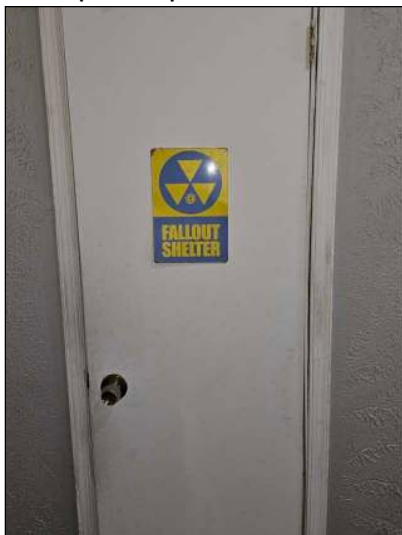
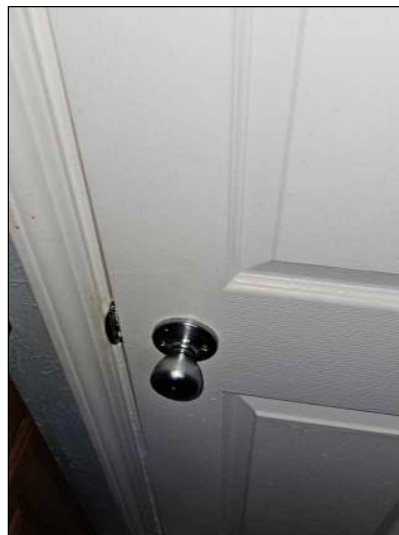
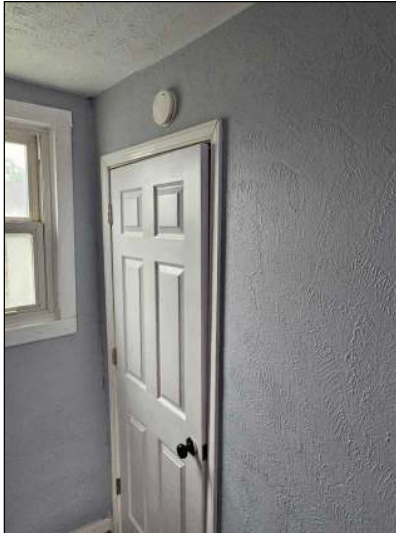
- Door doesn't latch properly.
- Door binds in jamb or floor.
- Majority of doors in the house do not close or latch properly. Recommend repair/replacement as needed by a qualified contractor.

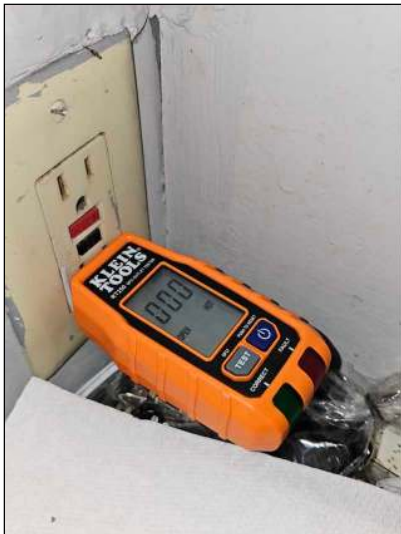
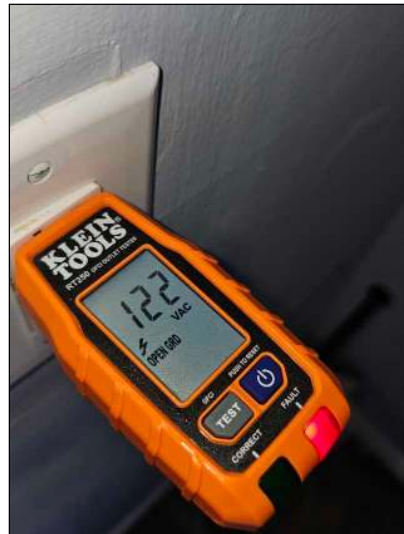
- GFCI outlet in the bathroom of unit #2 was not functional. No power indicated when tested and would not reset. Recommend replacement by a licensed electrician.
- GFCI outlet in the bathroom for unit #1 was found to have an open ground fault when tested. Recommend a licensed electrician to repair the issue.

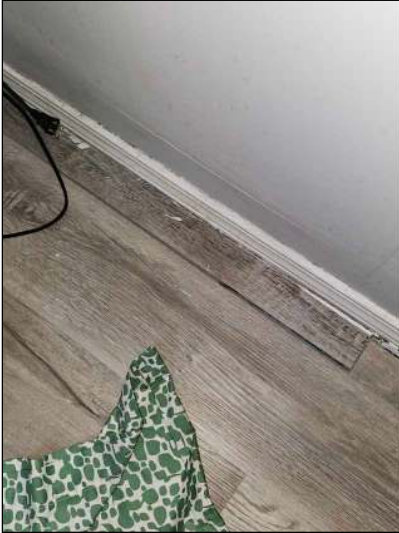
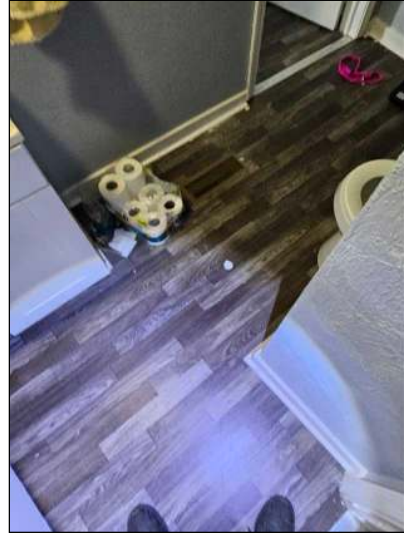
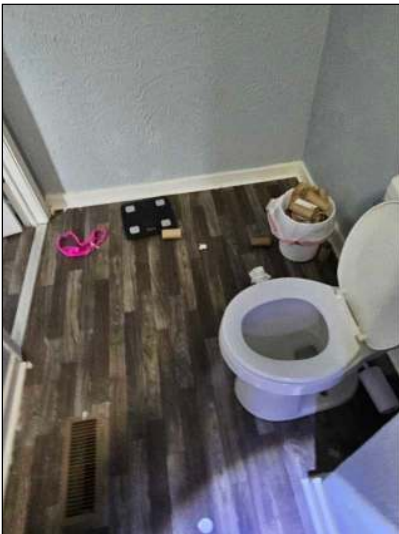
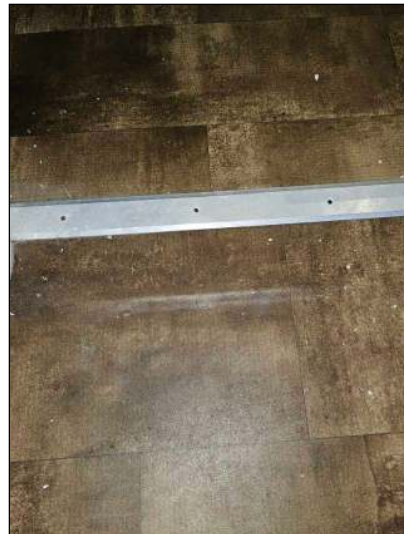
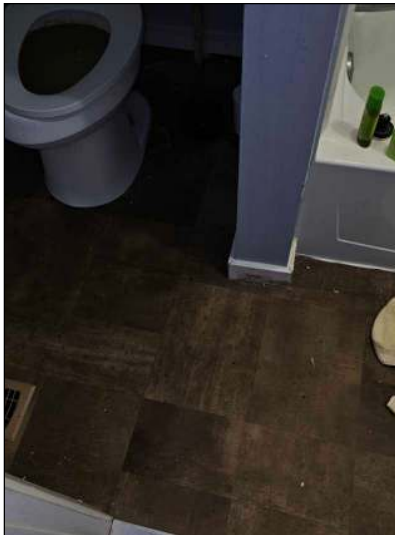
- Laminate floating floor system in unit #2 bathroom was installed with poor workmanship techniques, gaps are visible giving a less than appealing appearance and likely lowering the serviceable life of the flooring. Recommend monitoring for deterioration due to it being in an area with excess moisture.
- Vinyl flooring is rippled in the bathrooms of unit #1. Possible tripping hazard and could cause premature wear of the material. Recommend monitoring and replacing as necessary by a qualified contractor.
- Recommend review for repair or replacement as necessary.

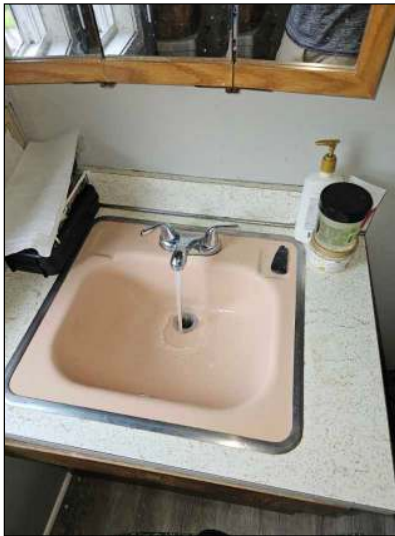
- **\*\*DRAINS\*\***
- No issues were observed with the sink drain at the time of inspection.
- **\*\*SUPPLY\*\***
- Operated normally, at time of inspection.
- Sink in unit #2 bathroom was functional at the time of inspection but is most likely beyond its normal life expectancy. Recommend considering replacement by a qualified contractor and licensed plumber.

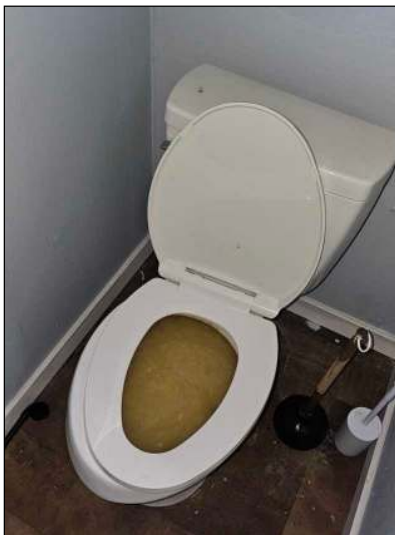
- Toilet in Unit #1 bathroom off of the kitchen was clogged and would not drain. Recommend further evaluation by a licensed plumber.

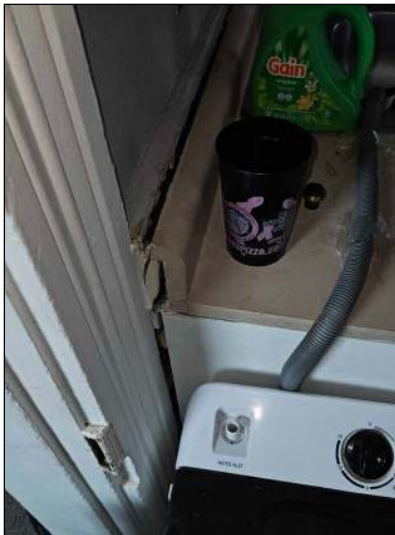
- Cabinets appeared to be beyond the expected lifespan. Consider upgrading
- Some cabinet doors need magnets or hardware to stay shut. Repair as needed.
- Some cabinet drawers need hardware repair/adjustment (to stay shut). Repair as needed.

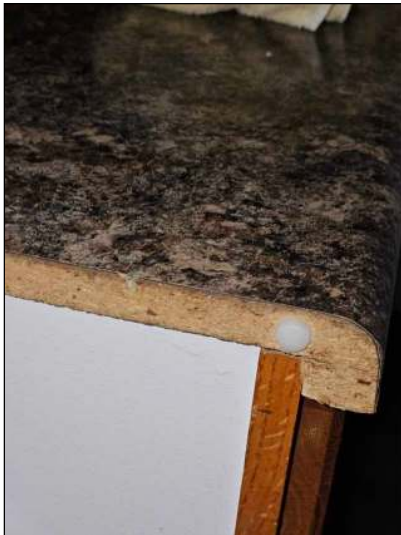
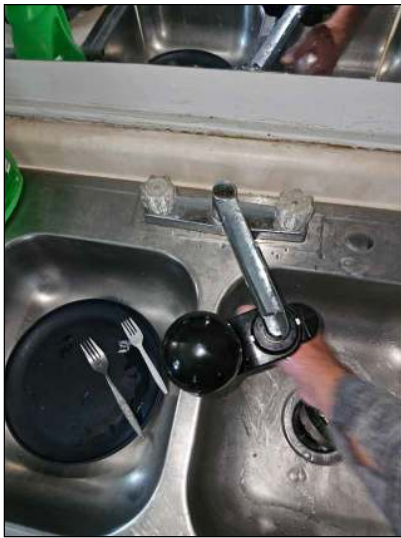
- Plastic laminate tops noted.
- Particle wood exposed on edge of the countertop in the kitchen of unit #1. This makes the countertop susceptible to moisture damage. Recommend repair by a qualified contractor.
- Countertop in the kitchen of unit #2 appears to be beyond the expected life span of the material. Recommend considering new cabinets and countertop.

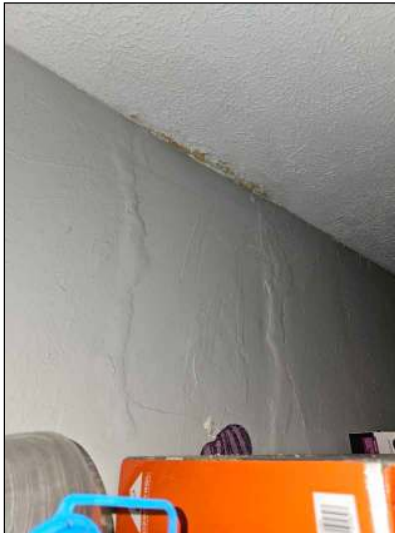
- Minor damage noted from what appears to be from excess moisture in the kitchen area of unit #2. No active leaks were observed at the time of inspection. This area was also near the chimney in the attic. Water damage may be from poorly installed and missing flashing around the chimney on the roof. Recommend further evaluation by a qualified contractor.

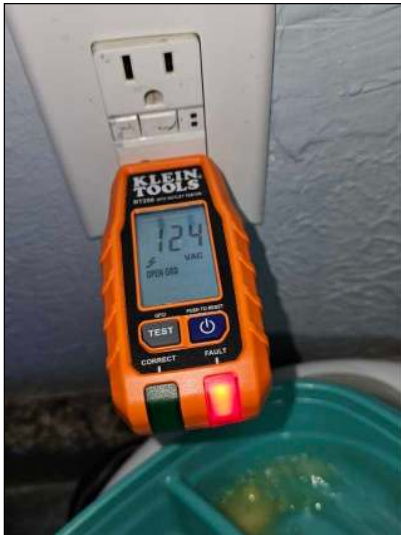
- Not all outlets in the kitchen were GFCI protected. While it may not have been required when the house was built. We suggest buyer consider upgrading with GFCI's at all receptacles near water sources.
- GFCI tested and found to be improperly wired. Potential shock hazard in a high moisture area. Recommend review and repair by a licensed electrician.

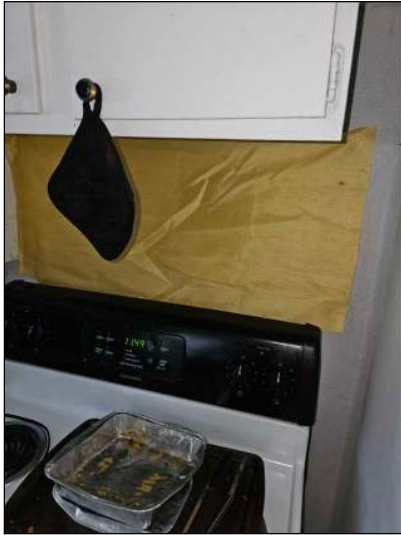
- Limited review due to storage of personal property and finished walls.
- There is evidence of moisture entering structure in the kitchen in unit #2. We recommend contacting a contractor experienced in exterior systems to evaluate the area and suggest repair options.
- Paper covering wall above stove is possible obstructing damage to the wall.

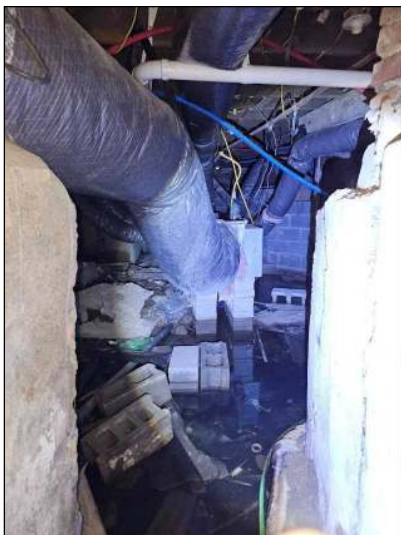
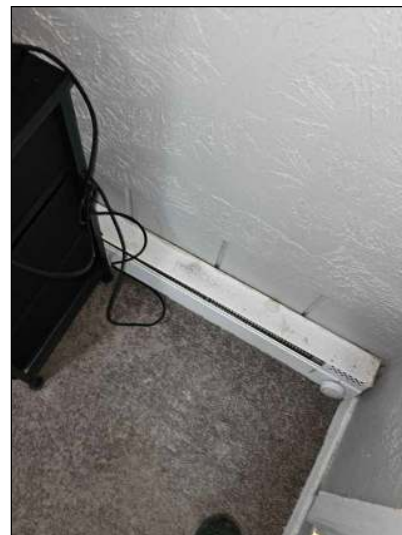
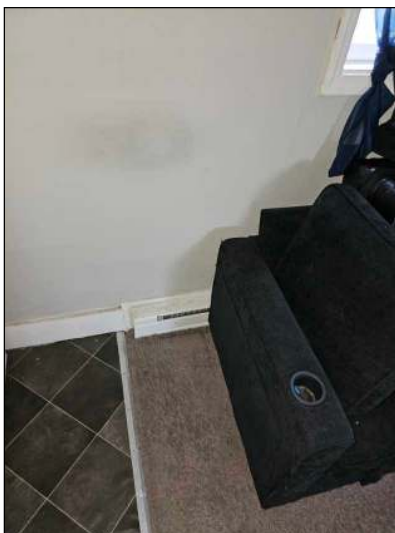
- The furnace could not be inspected due to outside temperature and standing water in the basement. Recommend having the heating system further evaluated by a licensed HVAC contractor when the water issue is resolved.

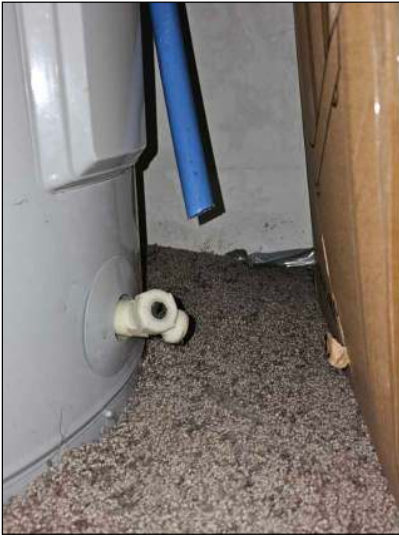
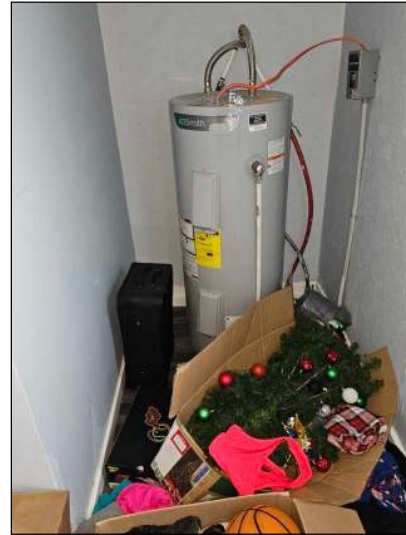
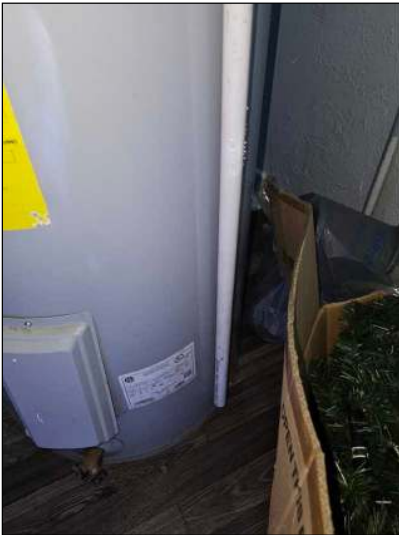
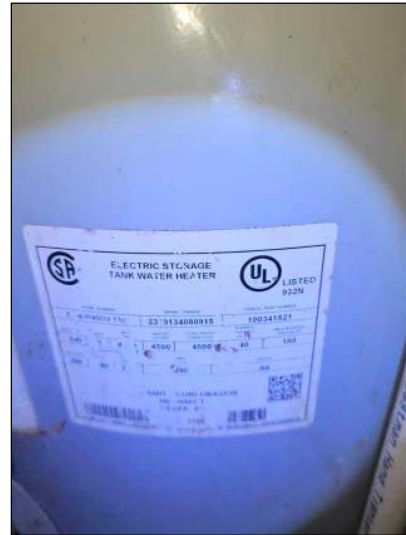
- The water heater enclosure is dirty. We recommend cleaning the enclosure.

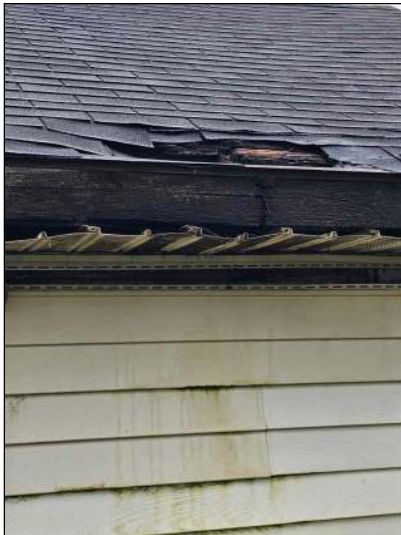
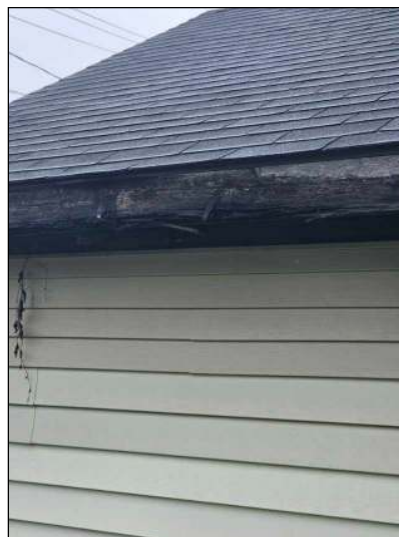
## 1. Roof Condition

- Some shingles and/or tabs missing.
- Some shingles damaged.
- Roof sheathing has been damaged.
- Indications of past or present water leaks, seeps, or condensation at eaves.
- Recommend further evaluation for repair/replacement by a qualified roofing contractor.
- Deterioration of exposed wood noted at the eaves around the garage. Recommend repair by a qualified siding contractor.

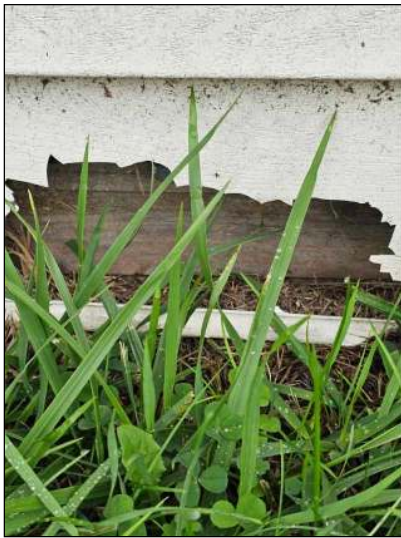
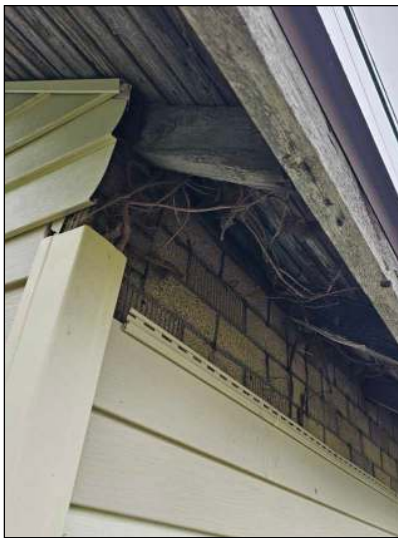
## 2. Walls

- The interior of the detached Garage/Shed could not be inspected due to restricted access. No key was available to unlock the exterior door at the time of inspection.
- Exterior siding is missing and damaged in multiple areas and is in close proximity to the ground. These issues can allow water damage to occur. Recommend repair/replacement by a qualified contractor.

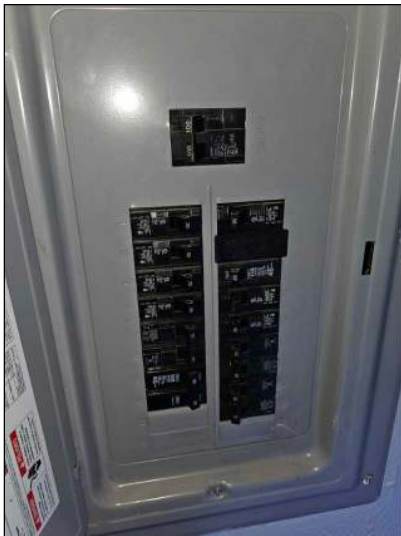
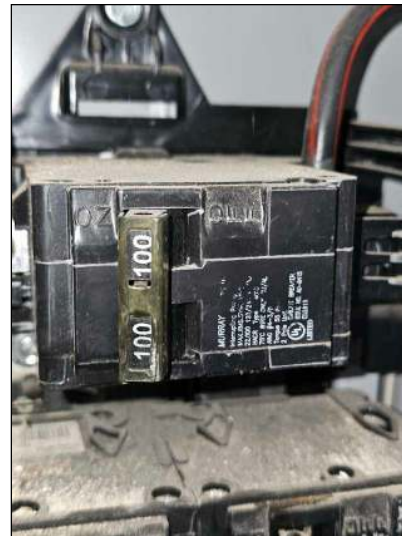
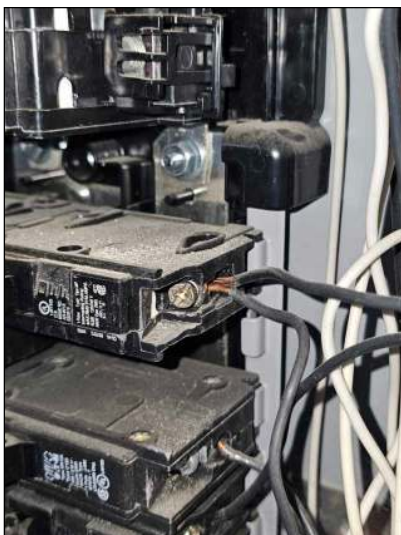
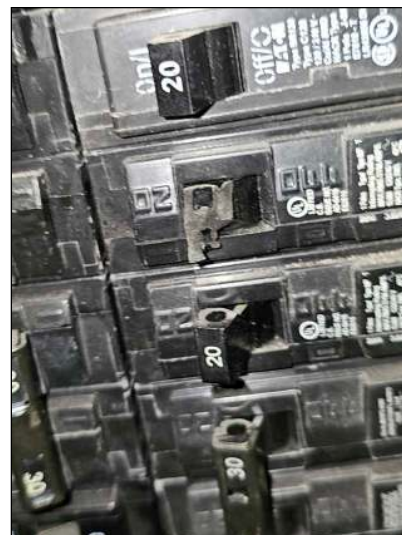
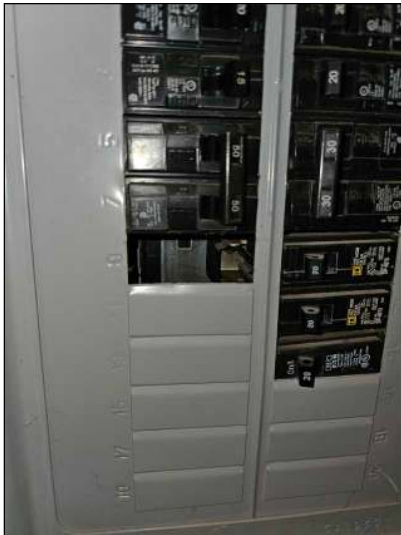
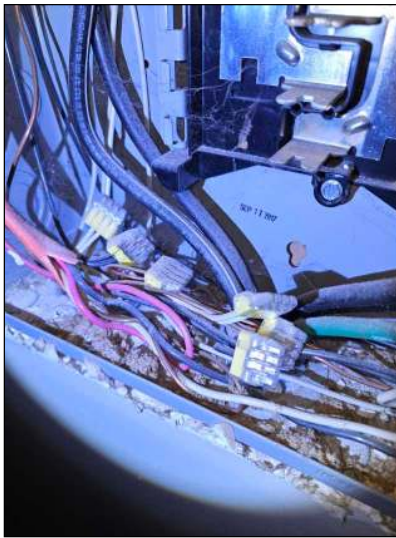
- Open breaker panel slot(s) at panel box cover in unit 2. Electrocution hazard. Recommend repair by a licensed electrician.

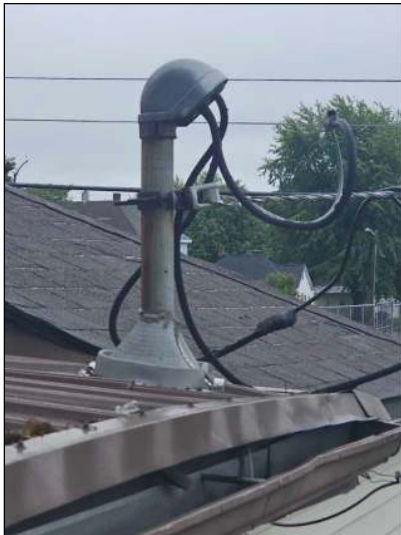
- There is an overhead service drop noted.
- The weather head is too low and the driploop is resting on the metal roof, this is a serious safety concern. Recommend review by a licensed electrician for repair or replacement, as necessary, prior to close.

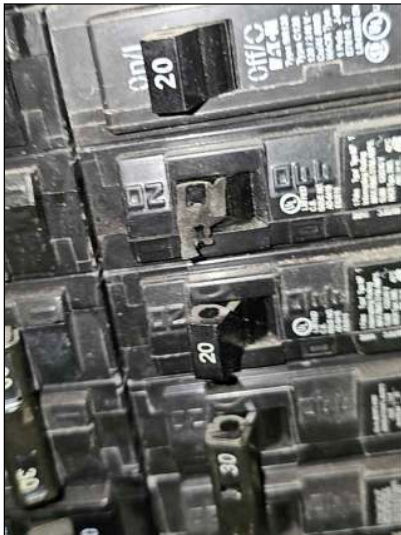
## 5. Breakers

- All of the circuit breakers appeared serviceable in both units with exception of one breaker that had a broken switch in unit 1. Recommend replacement by a licensed electrician.
- Double tapping observed in unit #1. Double tapping (i.e. 2 wires on a single pole breaker) can add to the load of the affected circuit causing a possible overload and tripping breakers, or result in loose connections and overheating of the breaker or connections. Recommend further evaluation and repair by a licensed electrician

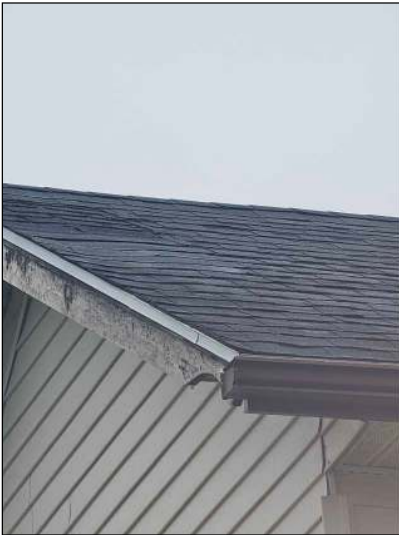
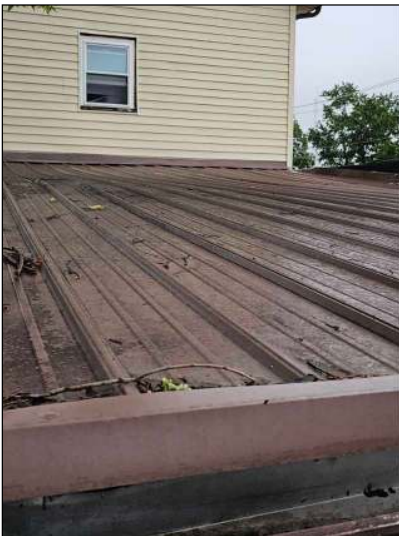
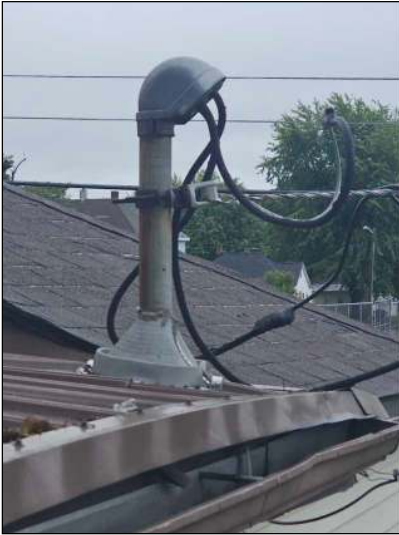
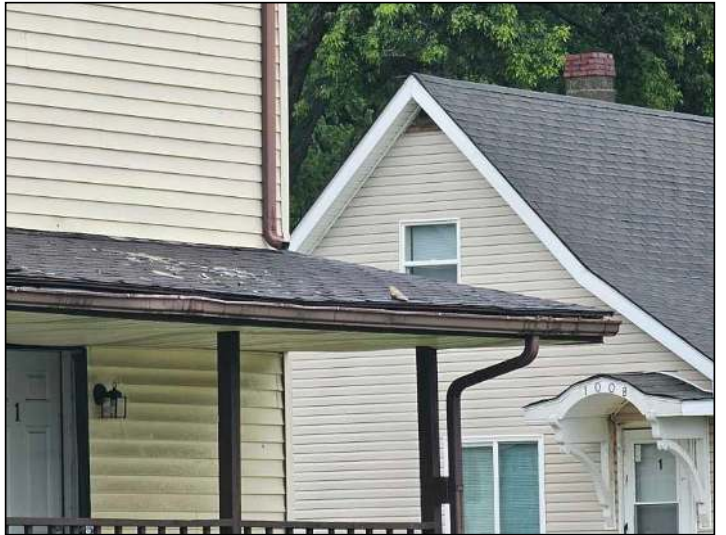
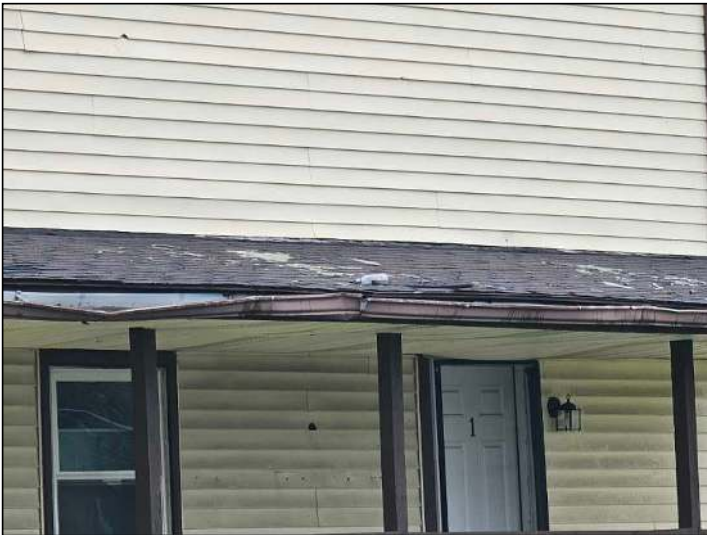
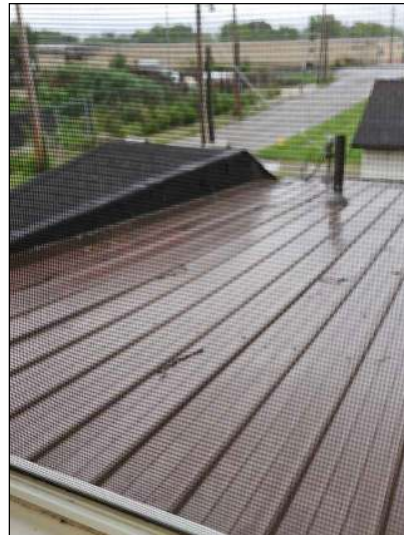
## 1. Roof Condition

- Some shingles &/or tabs missing.
- Some shingles curling.
- Some shingles damaged.
- Recommend roofing contractor to evaluate.

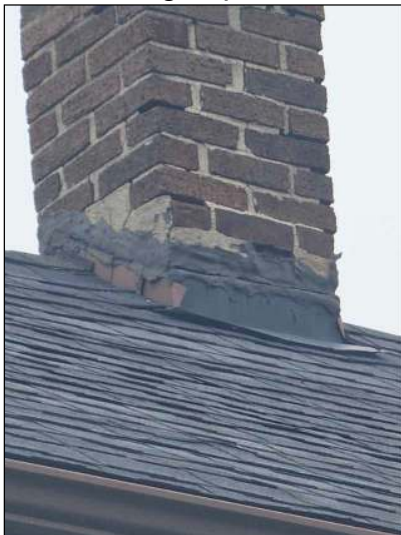
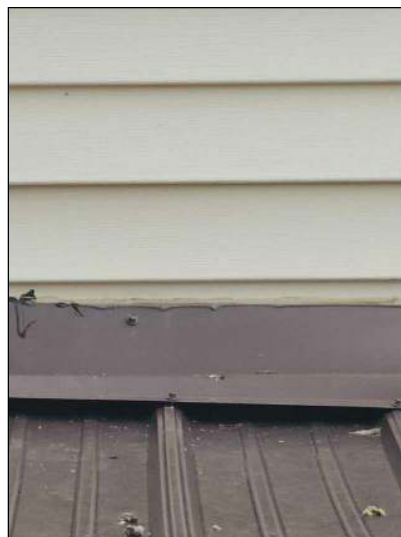
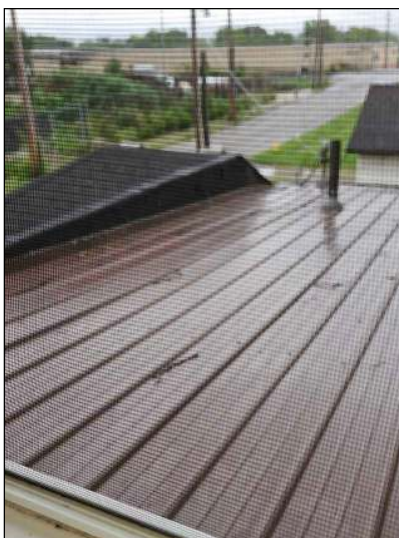
## 2. Flashing

- Flashing is missing around the chimney. Recommend a qualified roofing contractor to further evaluate the roof.
- The caulking was deteriorating on the flashing around the metal roof. Recommend resealing to prevent leaks.

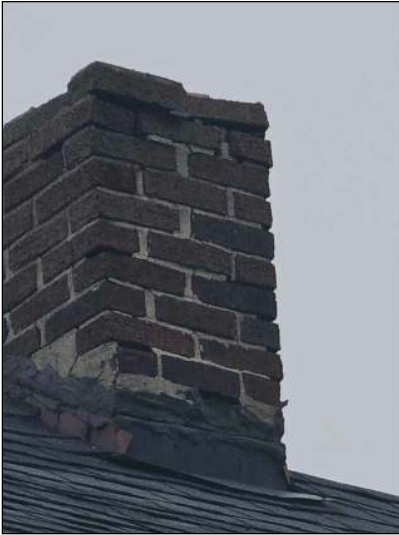
### 3. Chimney

- No chimney cap visible from inspection level. Recommend installation to prevent weathering, water intrusion, and nesting of wildlife.
- Chimney Mortar shows sign of deterioration. Recommend having repaired as necessary.
- Brick and mortar deterioration observed; repair advised.

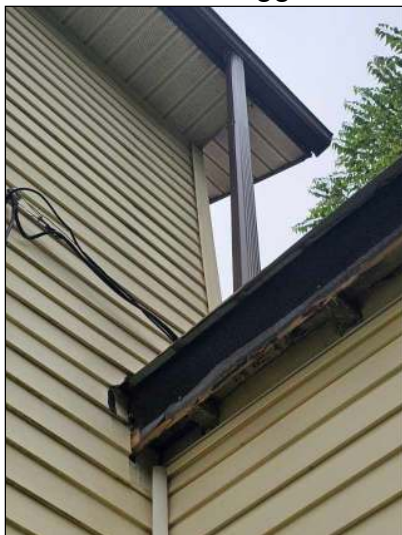
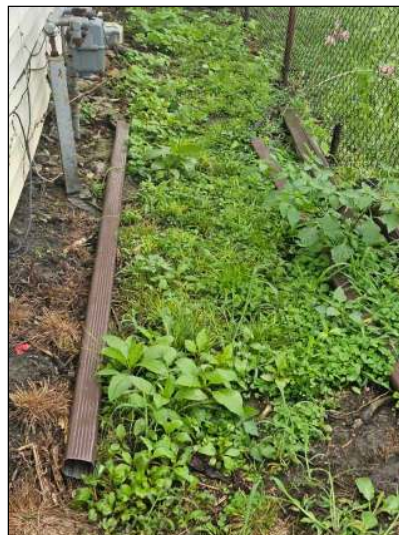
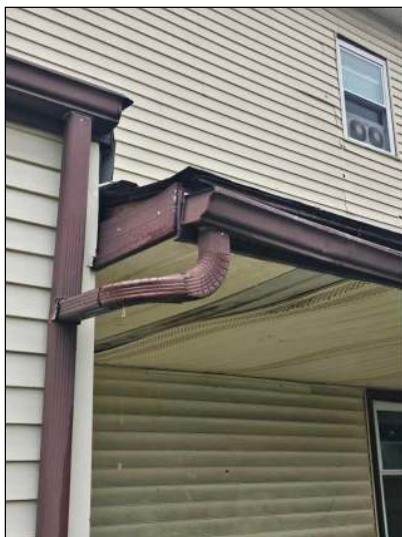
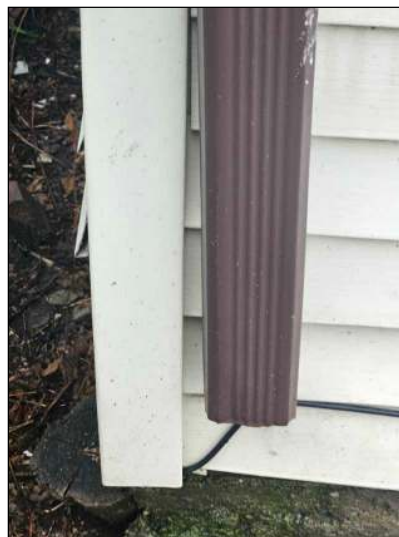
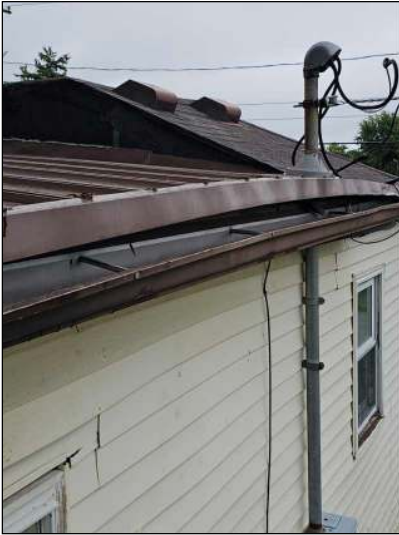
## 5. Gutter

- The gutters were damaged or missing in multiple areas around the house. Recommend further review and repair/replacement as necessary by a qualified gutter company to keep water away from the foundation.
- Missing/fallen downspouts noted.
- Downspout on the south side of the house discharges straight down towards foundation. Suggest adding a splash block or extension.

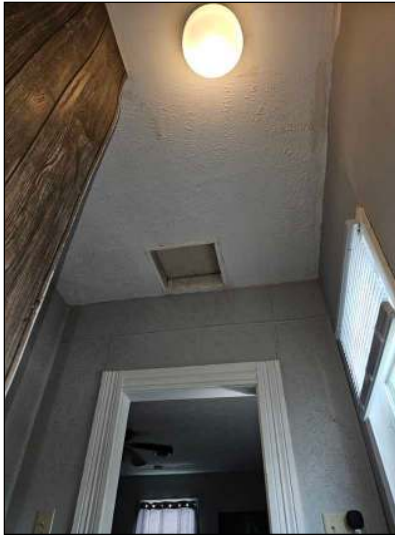
- \*\*Location of access\*\*
- Scuttle Hole located in the bedroom ceiling.
- Undersized or difficult to reach hatch making inspection limited.

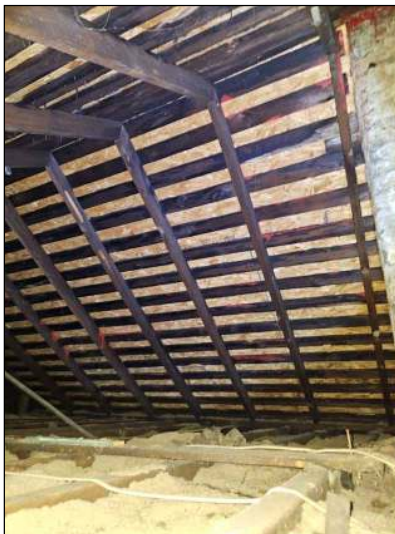
## 2. Structure

- Inspected from access hole only, limited space in attic prevented entry.

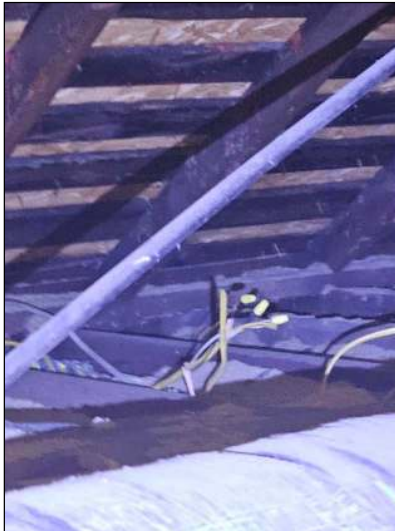
- Connections made outside of a Junction Box, which is a potential shock/fire hazard. Recommend repair by a licensed electrician.

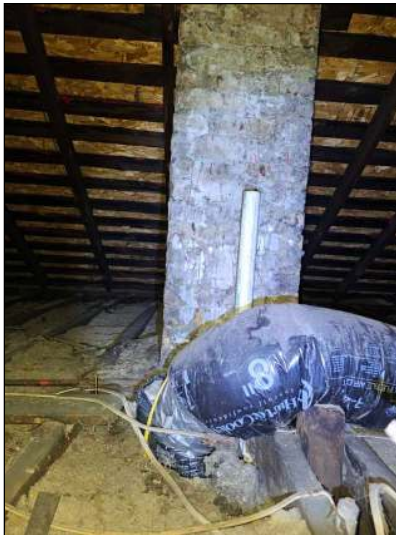
### 6. Attic Plumbing

- PVC plumbing vent noted
- Vent pipe does not extend to the exterior of the house. Recommend repair by a licensed plumber.

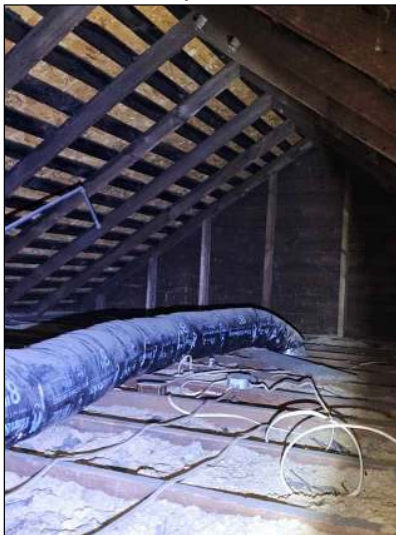
## 7. Insulation Condition

Depth: Insulation averages 3 to 4 inches. Recommend installing more.

- Insulation is sparse in some areas.
- Insulation that is settled does not perform to the R-Value that it once did.

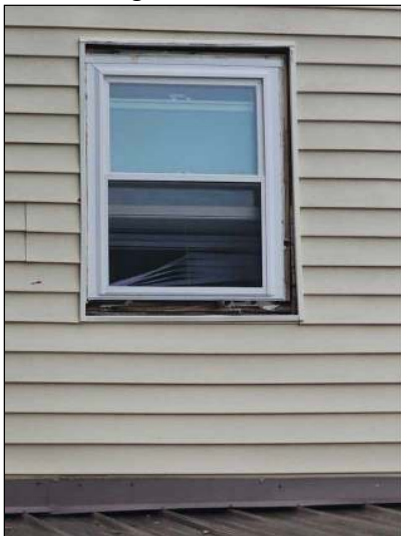
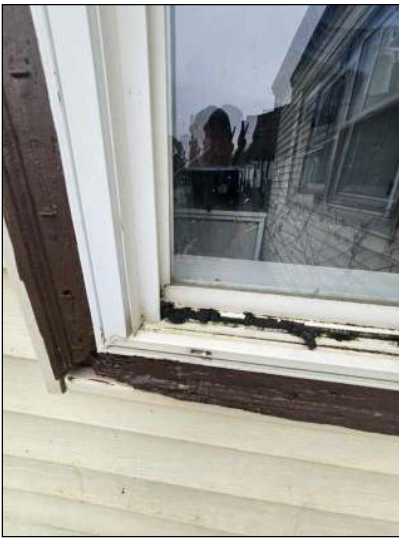
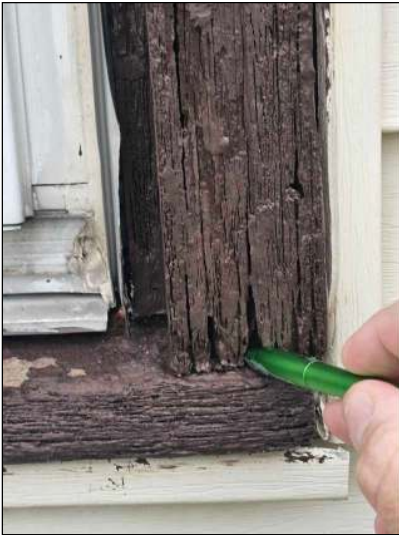
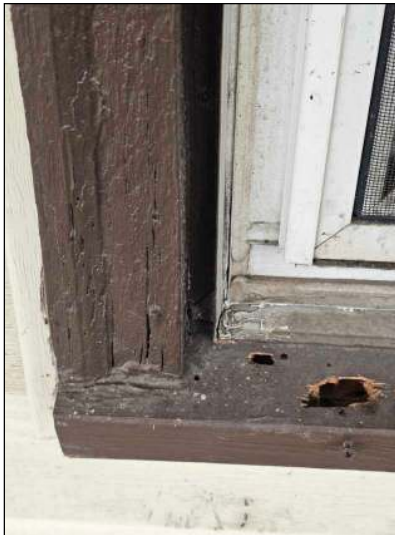
## 2. Window Condition

- Some window screens missing or damaged.
- Deteriorated exterior wood trim noted on several windows. Recommend repair/replacement by a qualified contractor.
- There is exposed wood around several of the windows. This can cause moisture damage. Recommend repair by a qualified siding contractor.
