# *Complete Home Inspections LLC*

## Property Inspection Report

1001 W 1st St., Muncie, IN 47305

Date of Inspection: 8/2/2026 Time: 10:00am

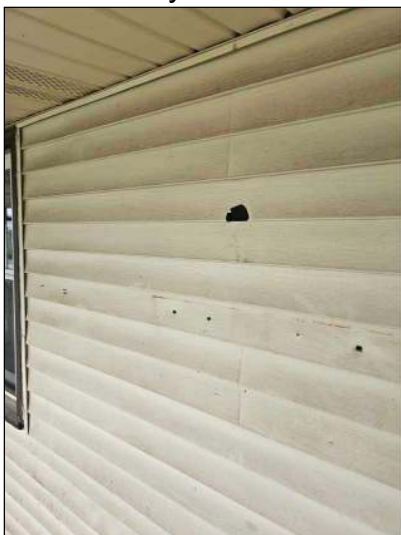
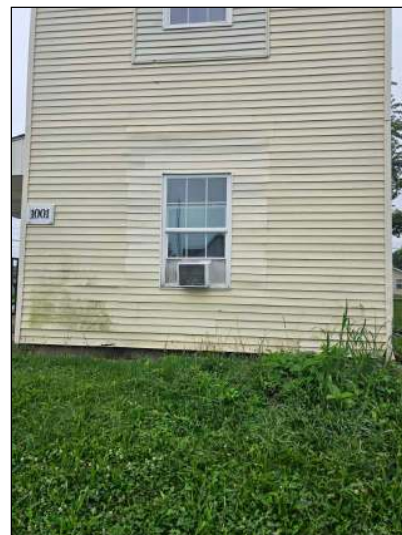
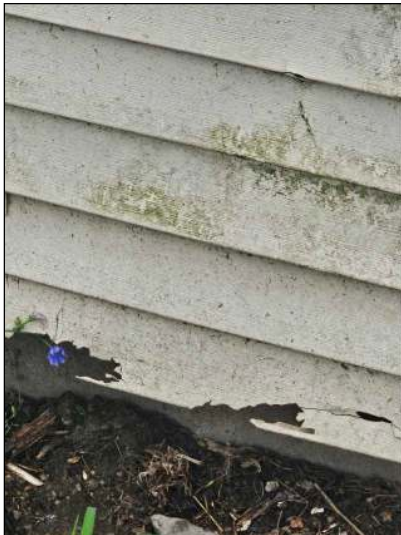
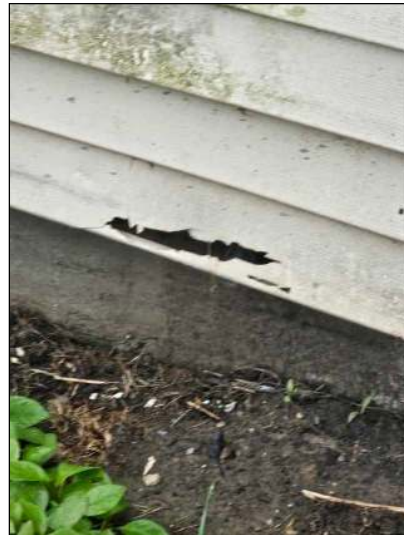
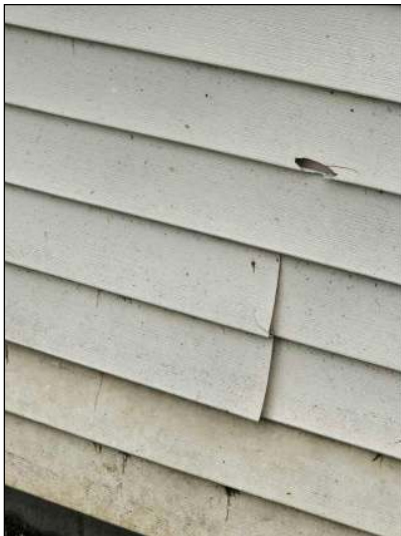
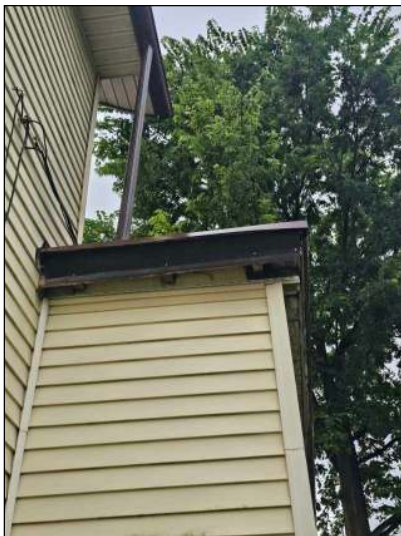
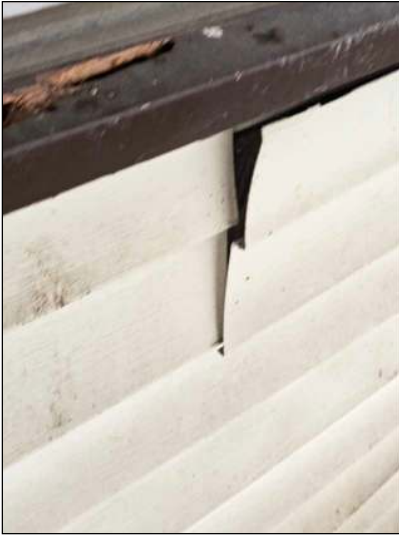
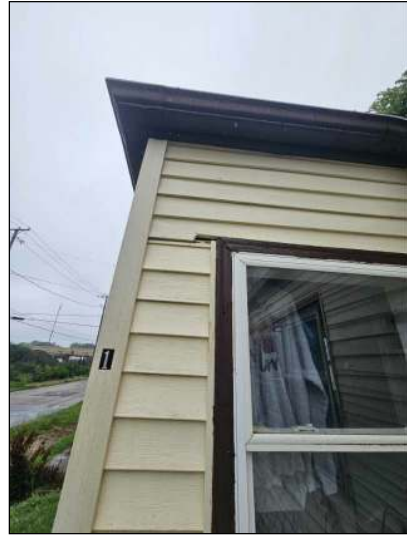
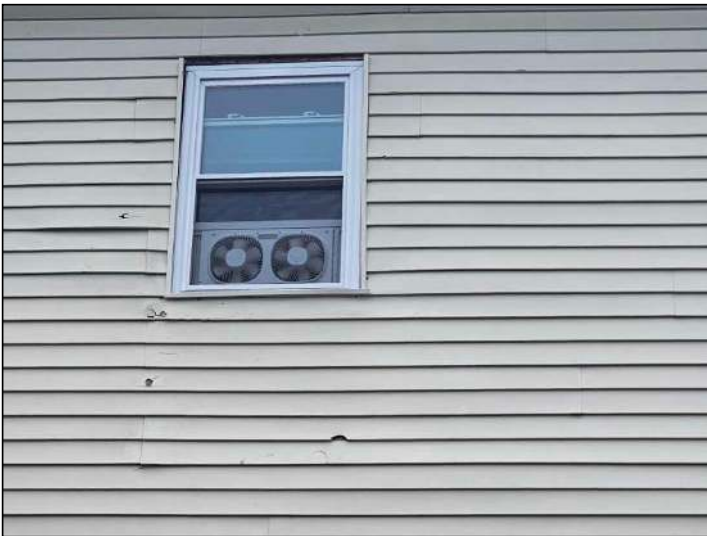
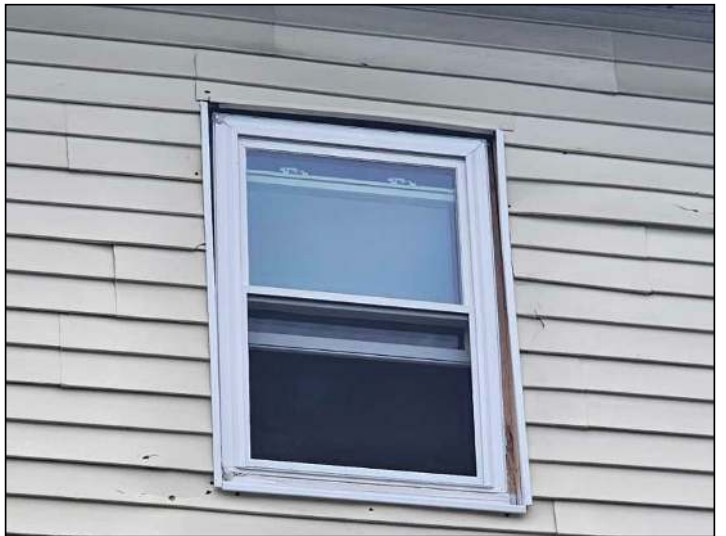
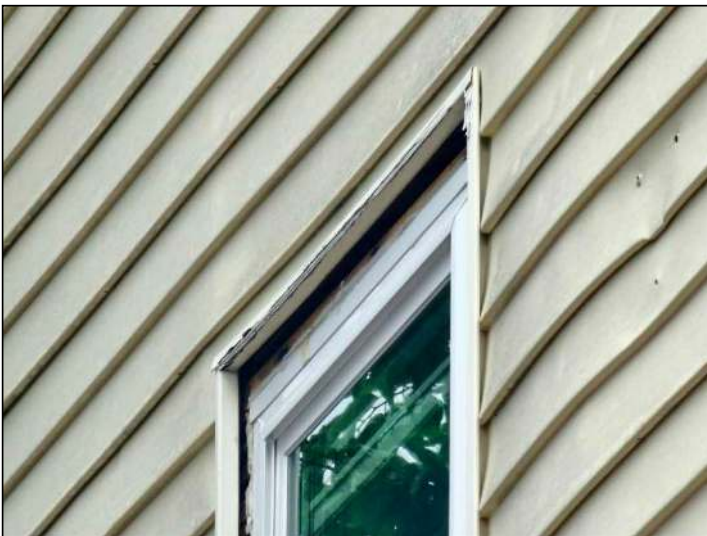
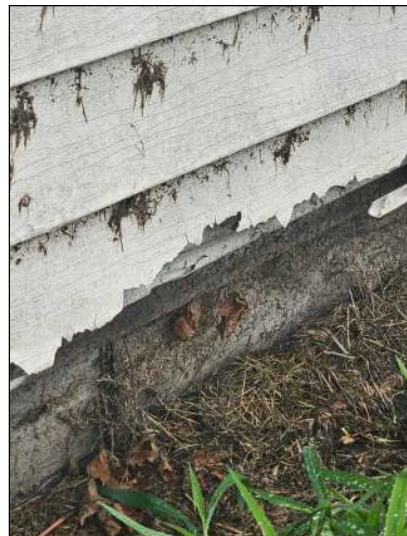
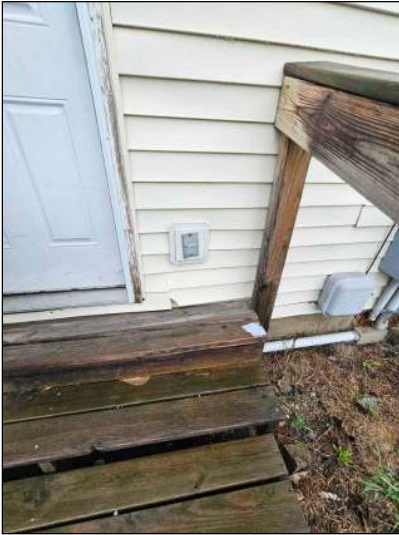
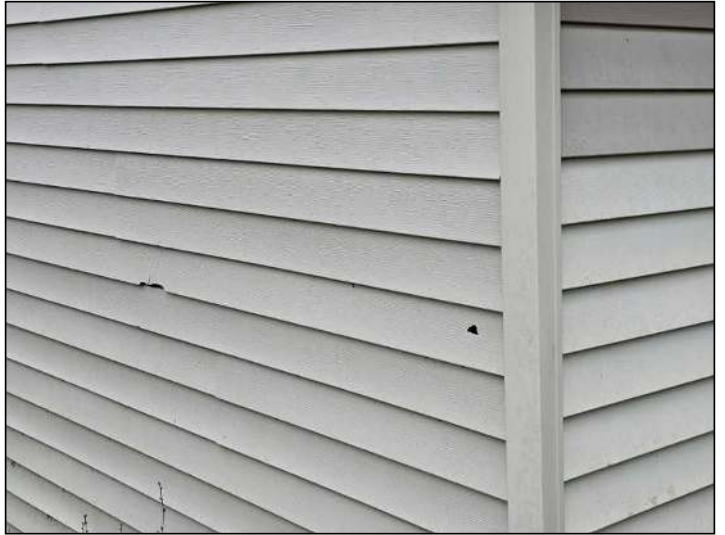
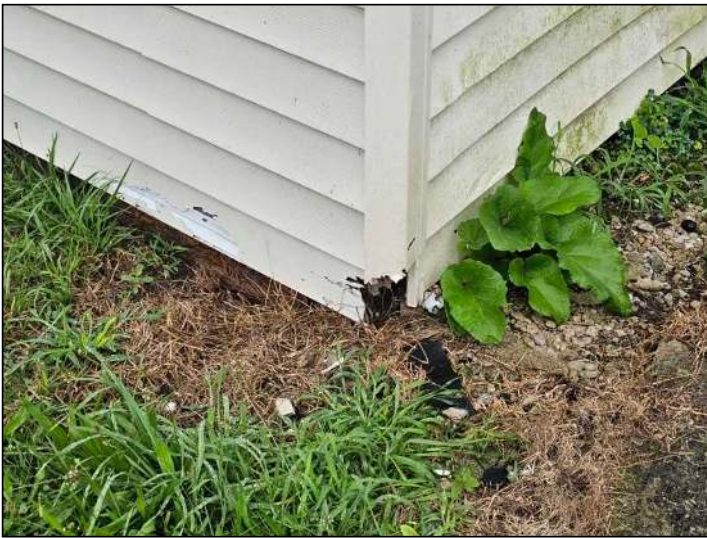
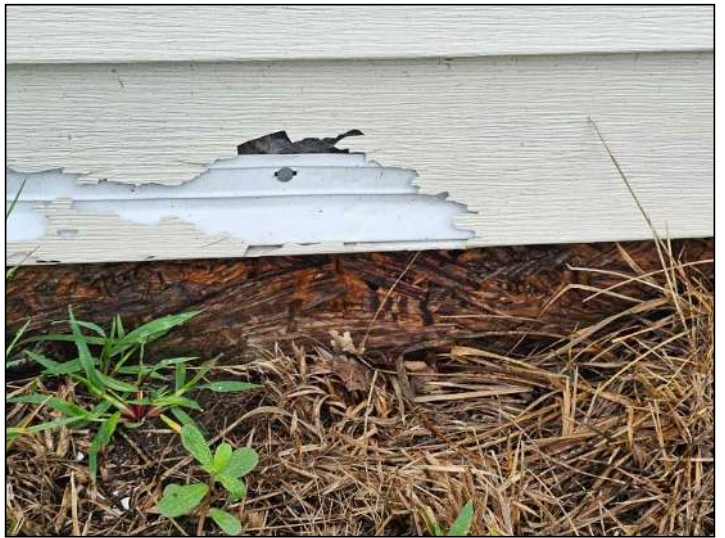
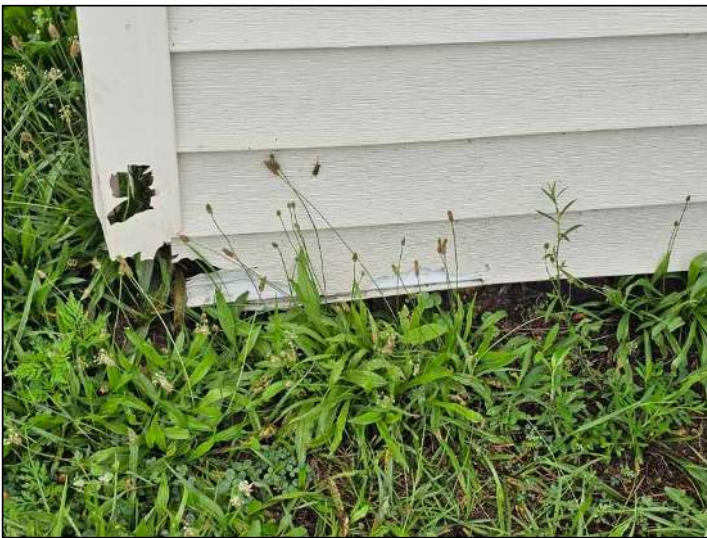
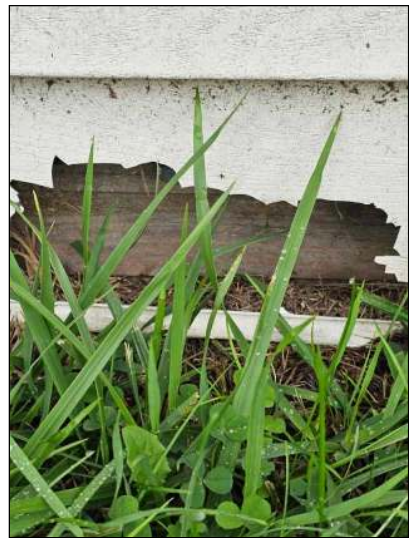
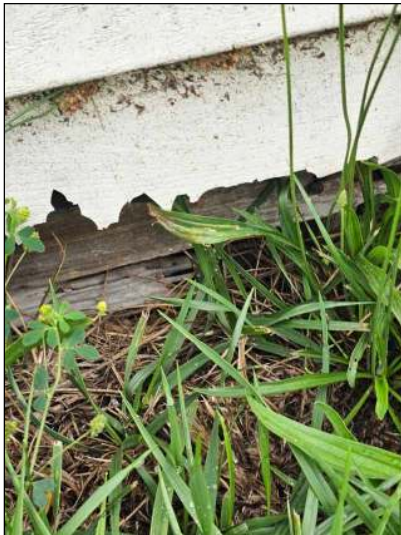
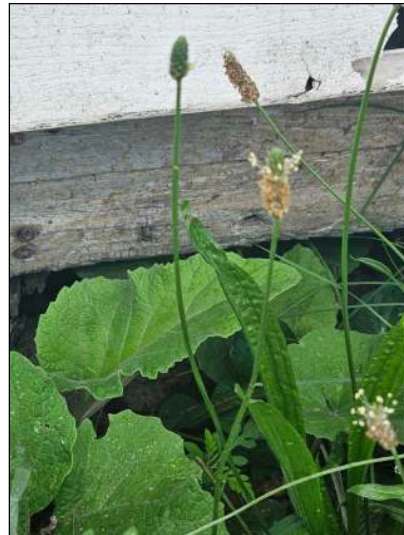
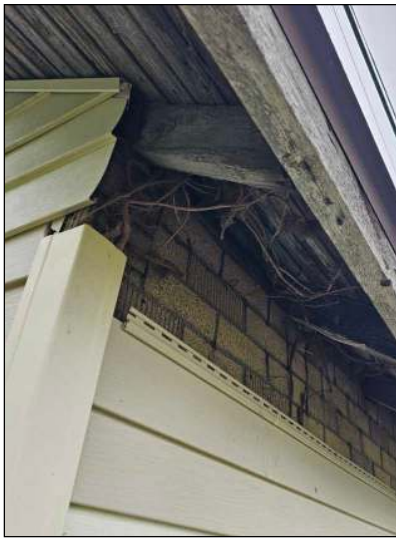
### 3. Siding Condition

- The siding is in close proximity to the soil. This may provide entrance for moisture or insects.
- Vinyl siding missing, damaged or improperly installed in multiple areas exposing the wood sheathing and can cause moisture damage. Recommend further evaluation by a qualified siding contractor.
- Warped siding present in some areas; recommend repair or replacement as necessary.
- Insect damage or activity suspected. Recommend further evaluation by a licensed exterminator.
- Some wood deterioration noted at garage - exterior personnel door frame base. Have repaired and inspected for wood-destroying insect damage.
- Moderate damage to vinyl: The vinyl siding covering exterior walls had areas of moderate damage which should be repaired to prevent moisture intrusion of the wall assembly.

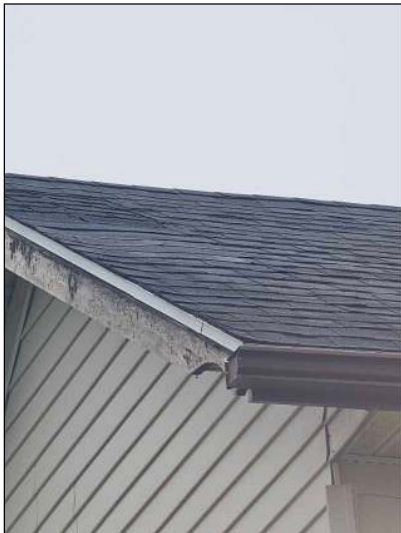
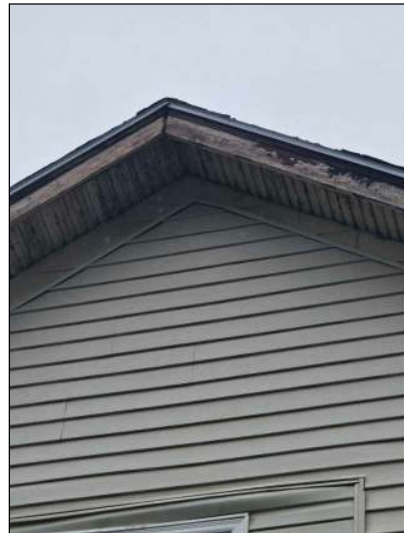
#### 4. Eaves & Facia

- In the inspectors opinion the trim is near the end of its useful life
- Moisture damage, wood rot, observed. Recommend review for repair as necessary by a qualified contractor.

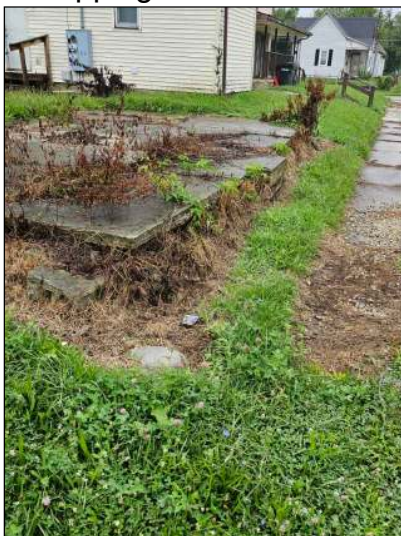
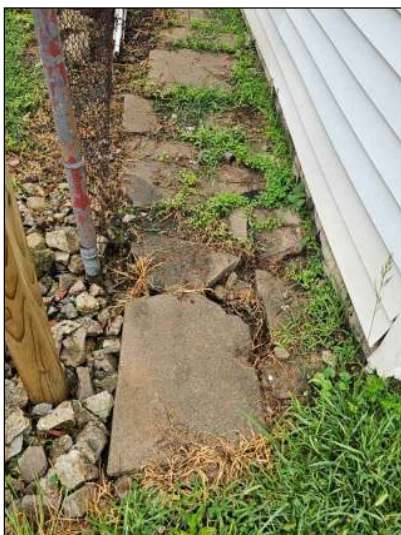
## 1. Driveway and Walkway Condition

- There are numerous areas of damaged concrete surfaces. Concrete replacement is expensive. Recommend a concrete specialist provide an estimate for repair and or replacing.
- Monitor: Surface deterioration observed at the concrete surface.
- Potential Trip/fall Hazard(s) at the sidewalk steps and old concrete pad located in the backyard; monitor/ repair as necessary.
- Handrail on sidewalk steps is no graspable by today's standards and is a potential fall hazard. Recommend a qualified contractor to replace handrails.
- Sidewalk along the garage/shed is severely deteriorated and is a potential tripping/fall hazard. Recommend repair by a qualified contractor.

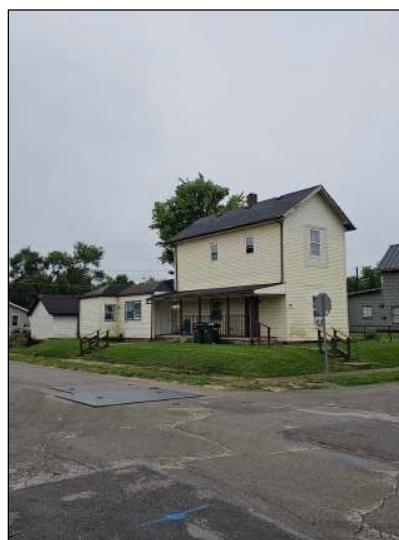
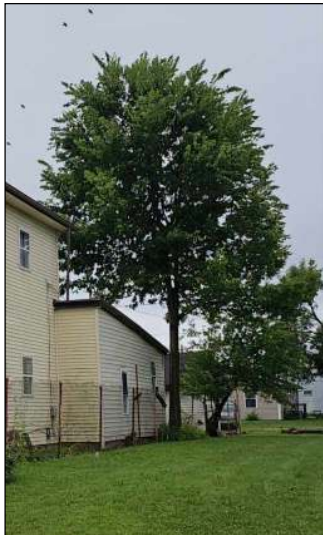
## 2. Grading

- The exterior drainage is generally away from foundation except on the west side of the house is flat. Evidence of moisture and organic growth present. Recommend further review by a qualified contractor.
- Low and settled grading was observed at north west corner. Fill as needed.

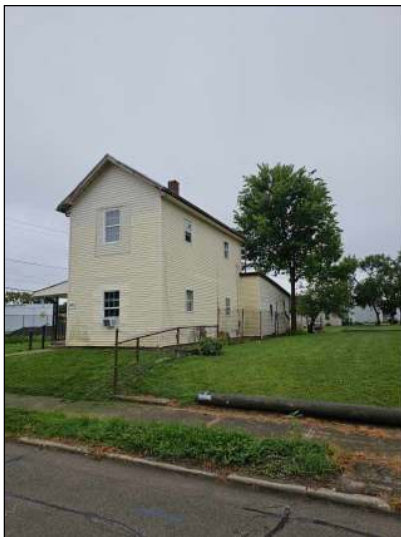
### 3. Vegetation Observations

- There is a tree on the neighboring property that is within 6 feet of house. Monitor for potential root damage to the foundation and possible damage to the roof from tree limbs.

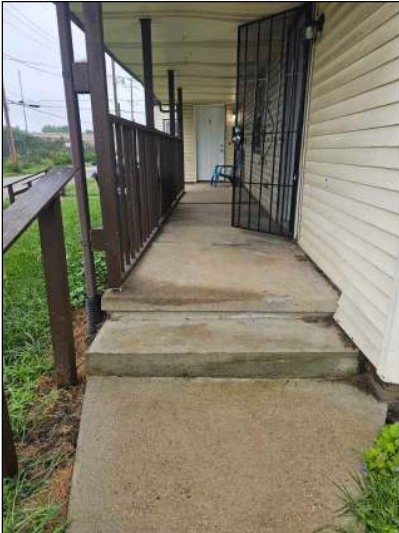
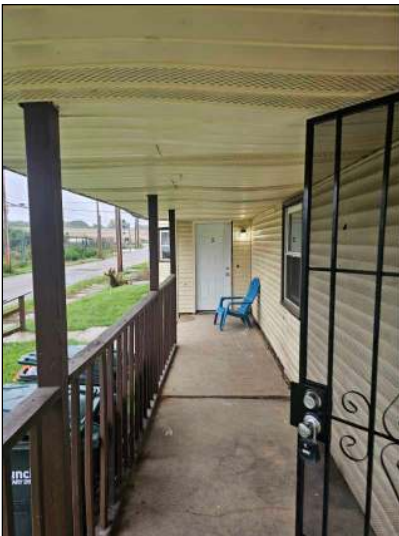
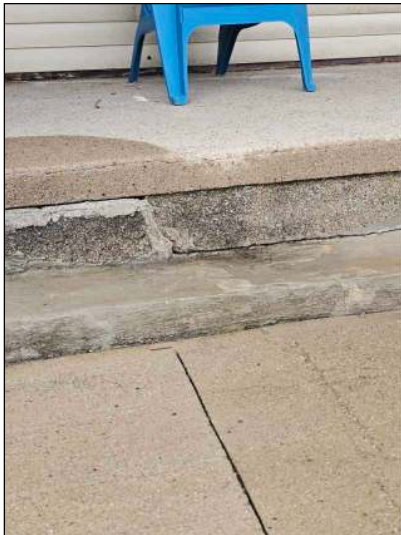
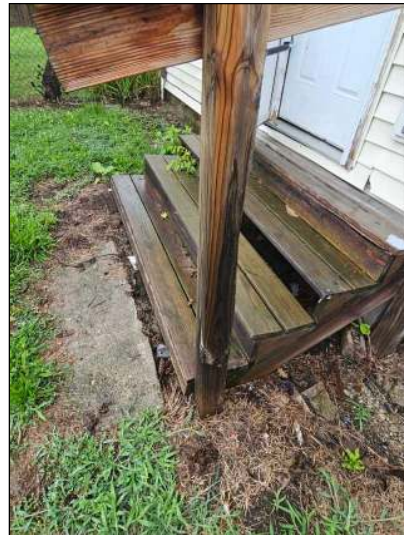
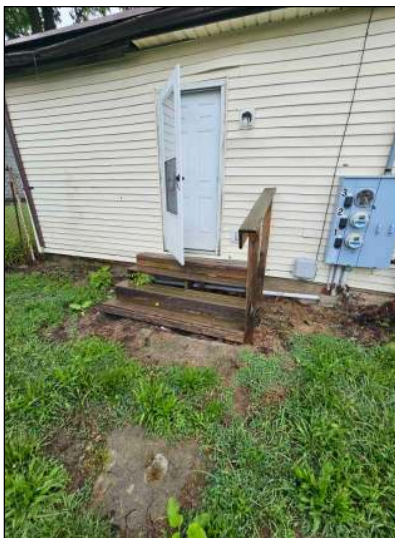
### 4. Patio and Porch Deck

- Balusters spaced too far apart.
- Non-conforming steps on the front patio, possible safety hazard.
- The steps are slanted on the back door of the downstairs unit and present a possible slipping hazard.
- Front concrete patio has a large settlement crack that caused the surface to be uneven. This is a potential tripping hazard. Recommend repair/replacement by a qualified contractor.

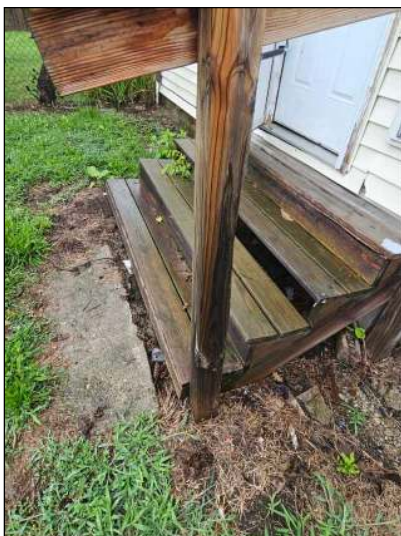
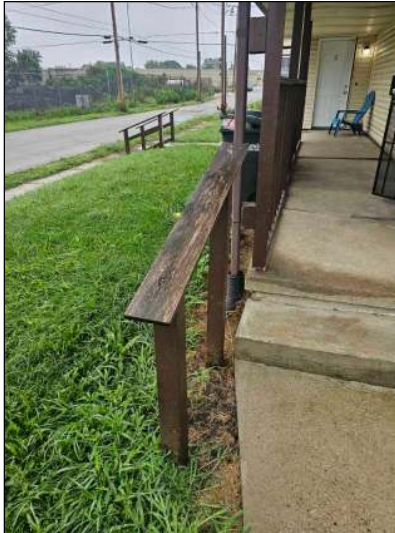
## 5. Stairs & Handrail

- Handrails are not graspable. By today's standards, rails should be configured so that a hand may grasp around a rail for safety. Recommend replacement by a qualified contractor.

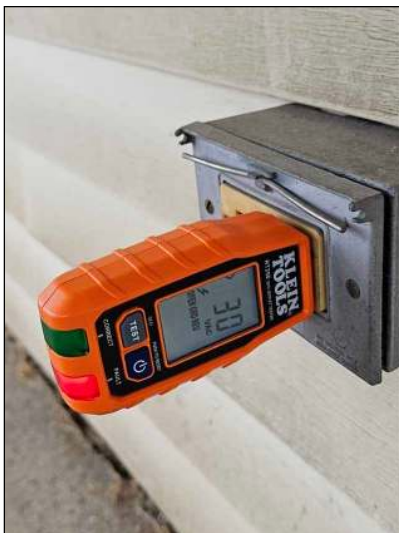
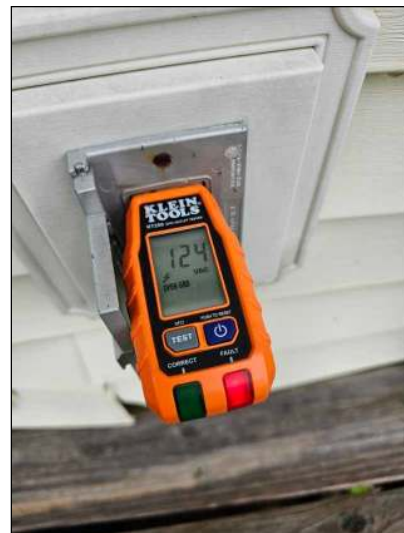
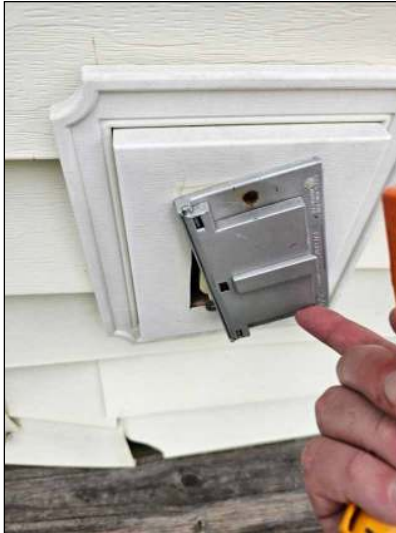
- Open ground/neutral observed on the GFCI outlet located on the front patio. This is an electrical shock hazard and repair/replacement should be completed by a licensed electrician.
- Both outdoor outlet covers were not secure to the receptacle boxes.
- Open ground fault observed on the outdoor GFCI outlet located near the back door of the property. Potential electric shock hazard. Recommend repair/replacement by a licensed electrician.

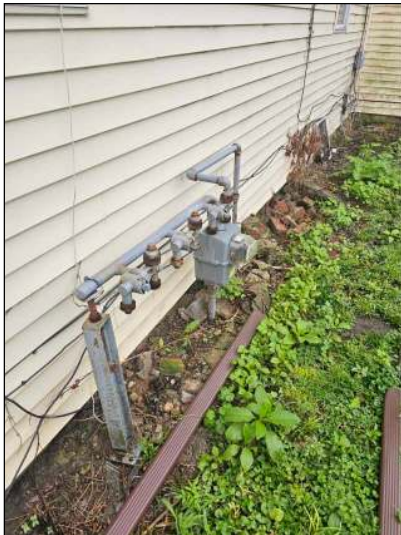
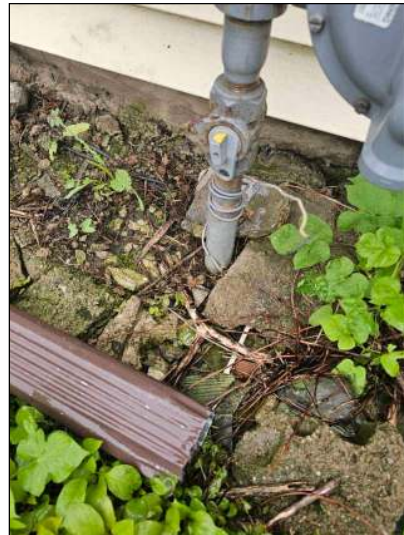
### 8. Main Gas Valve Condition

- No issues were observed with the exterior gas shutoff at the time of inspection.

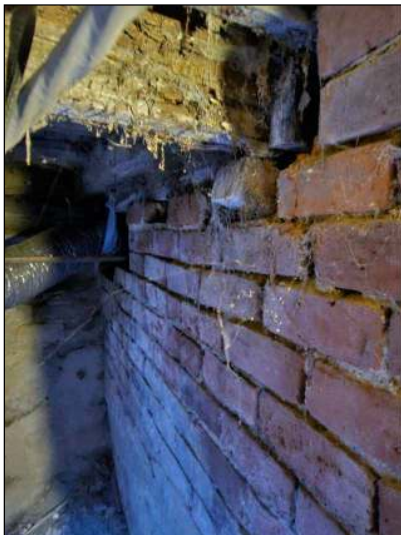
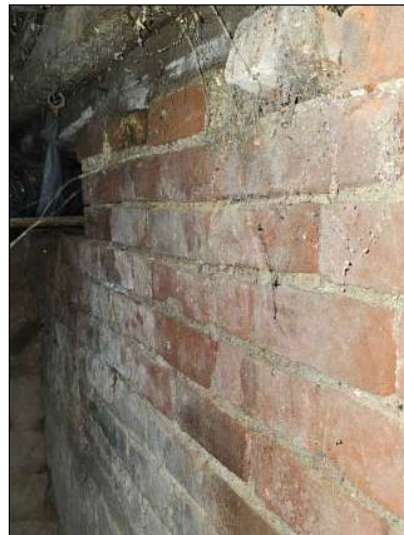
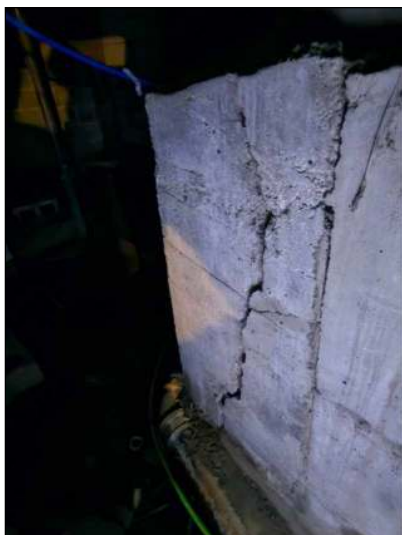
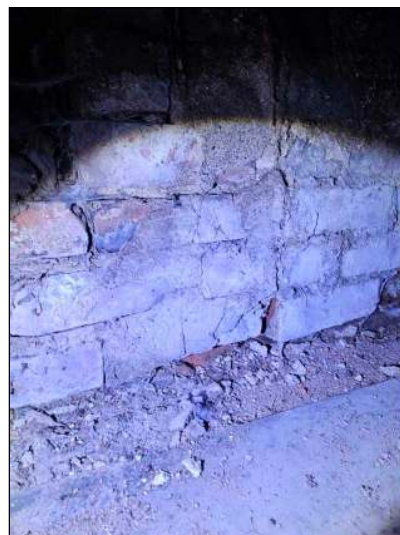
- It had rained heavily the day before and was misting at the time of inspection. Recommend having a licensed plumber
- Visible portions of foundation wall were dry at the time of the inspection.
- Large cracks were observed at the visible foundation walls. Repairs can be expensive and further settling or damage could occur. Recommend a Structural Engineer to provide a detailed analysis.
- The mortar in the brick foundation walls is deteriorating. Recommend further evaluation by a structural engineer.

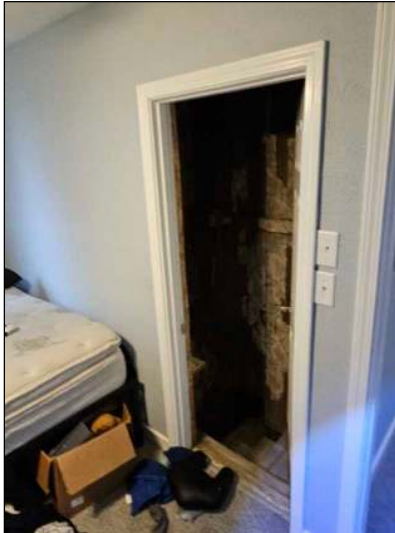
- Interior door was difficult to open and close. Recommend repair/replacement by a qualified contractor.

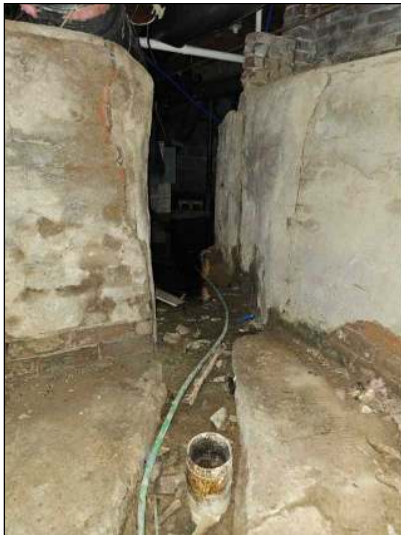
- Standing water noted on slab at time on inspection, review and repair needed to prevent possible water damage.
- Majority of the basement was inaccessible. Recommend a foundation specialist further evaluate the basement floor and walls once the standing water issue is resolved.

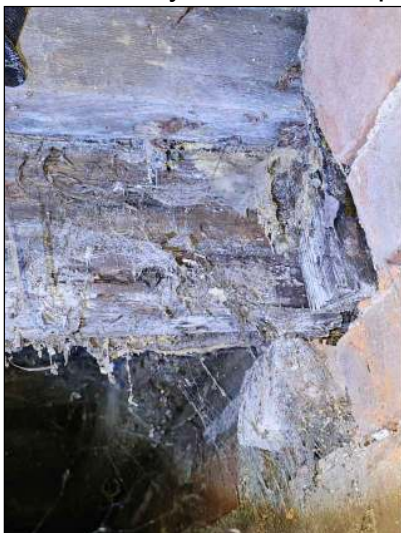
- **\*\*JOISTS\*\***
- Deterioration/ damage of one or more floor joist noted. Recommend review and repair by a Qualified Contractor to evaluate load bearing members.
- Recommend review of floor support system by a qualified contractor for any repair or upgrades needed to structure.
- Not fully visible for inspection due to lack of access to all areas.
